Subject : 1. Reinforcement of elevator actuator bellcrank inside the fuselage.
2. Correction of the Operation Manual.

Effectivity : All ASW 15s and ASW 15 Bs including its variants as motorgliders.

ASW 15, ASW 15 B
Technical Note
No.22

Alexander Schleicher
Segelflugzeugbau
6416 Poppenhausen

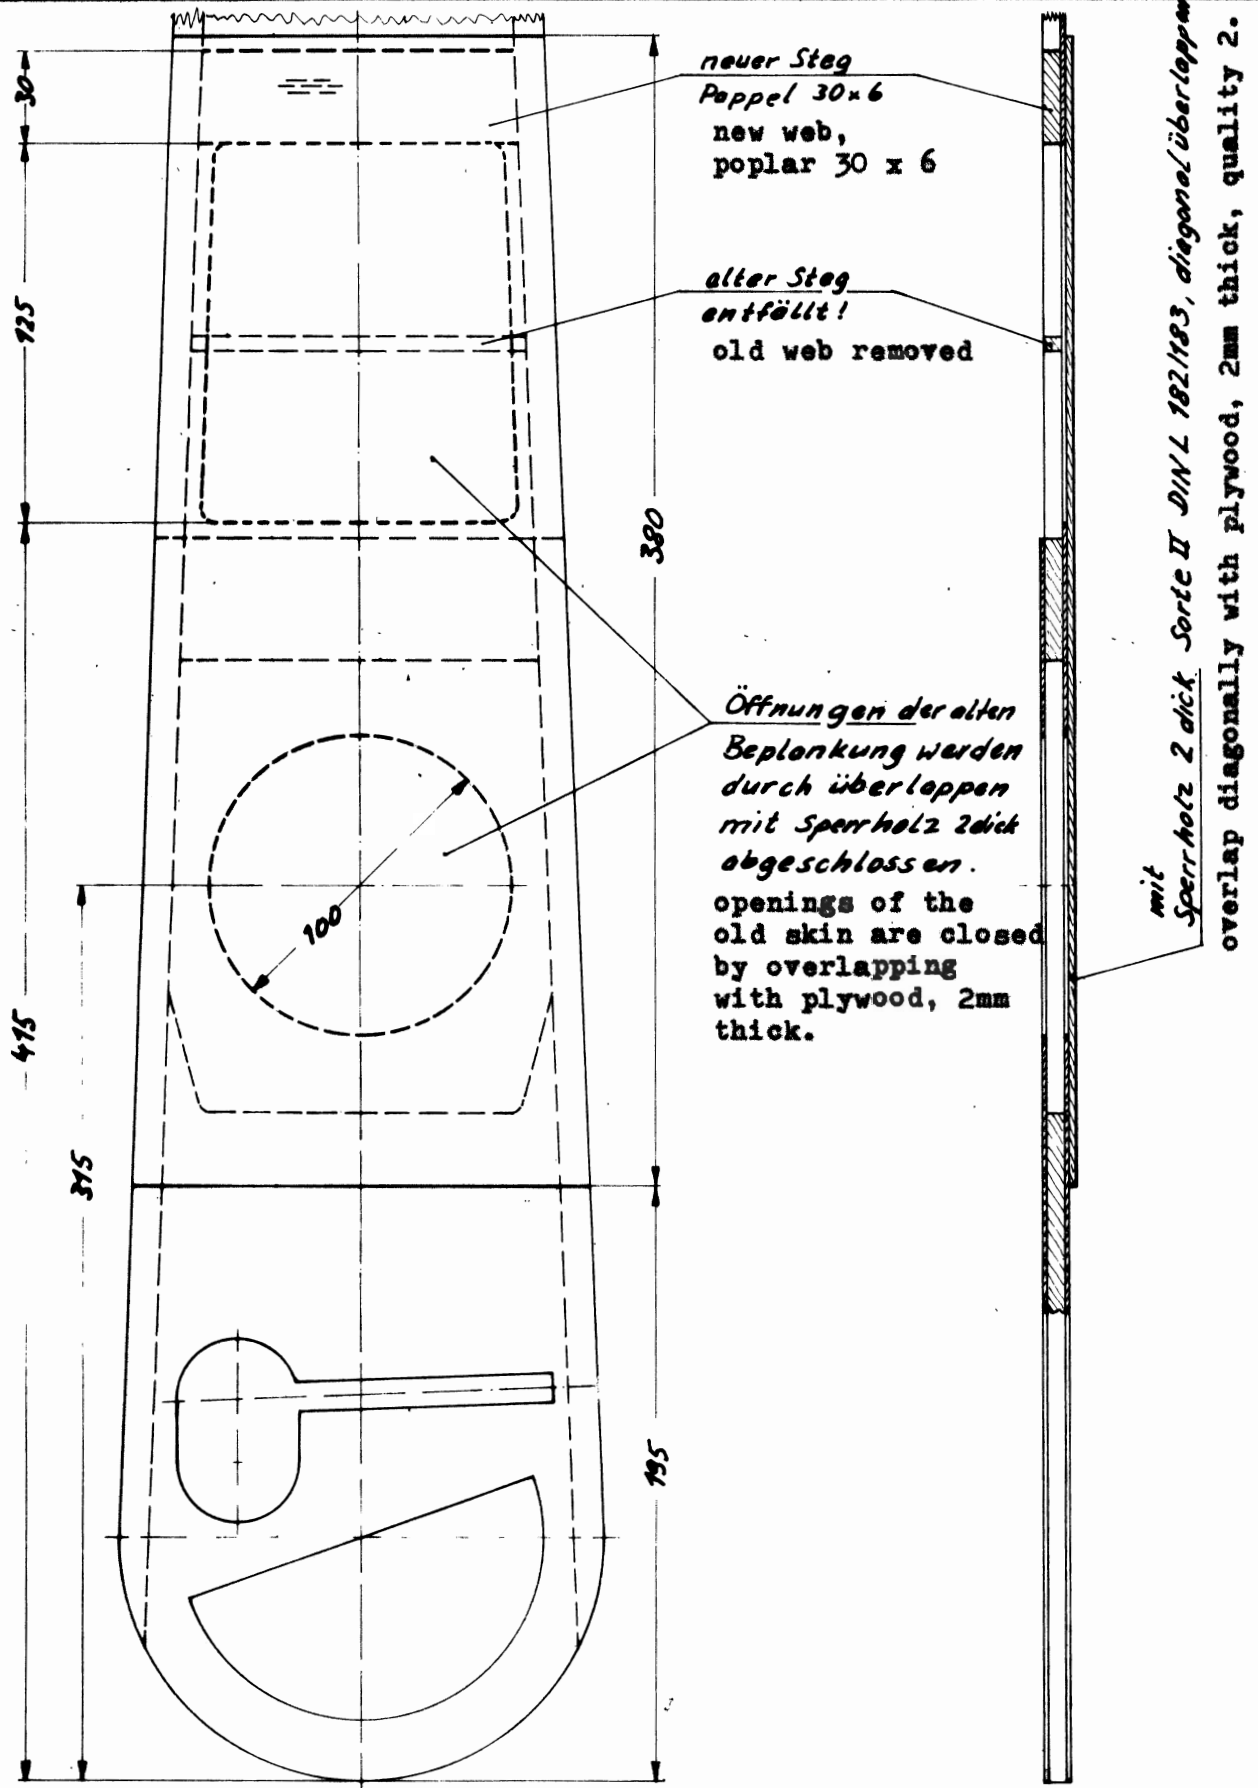
Vertical fin spar

An additional piece of wood (see drawing sheet no.1 of this TN) is glued to the fin spar.

The openings in the spar are closed by overlap joint with plywood, 2mm thick, as can be seen on drawing sheet no.1; do not forget to preserve all internal surfaces before closing the openings.

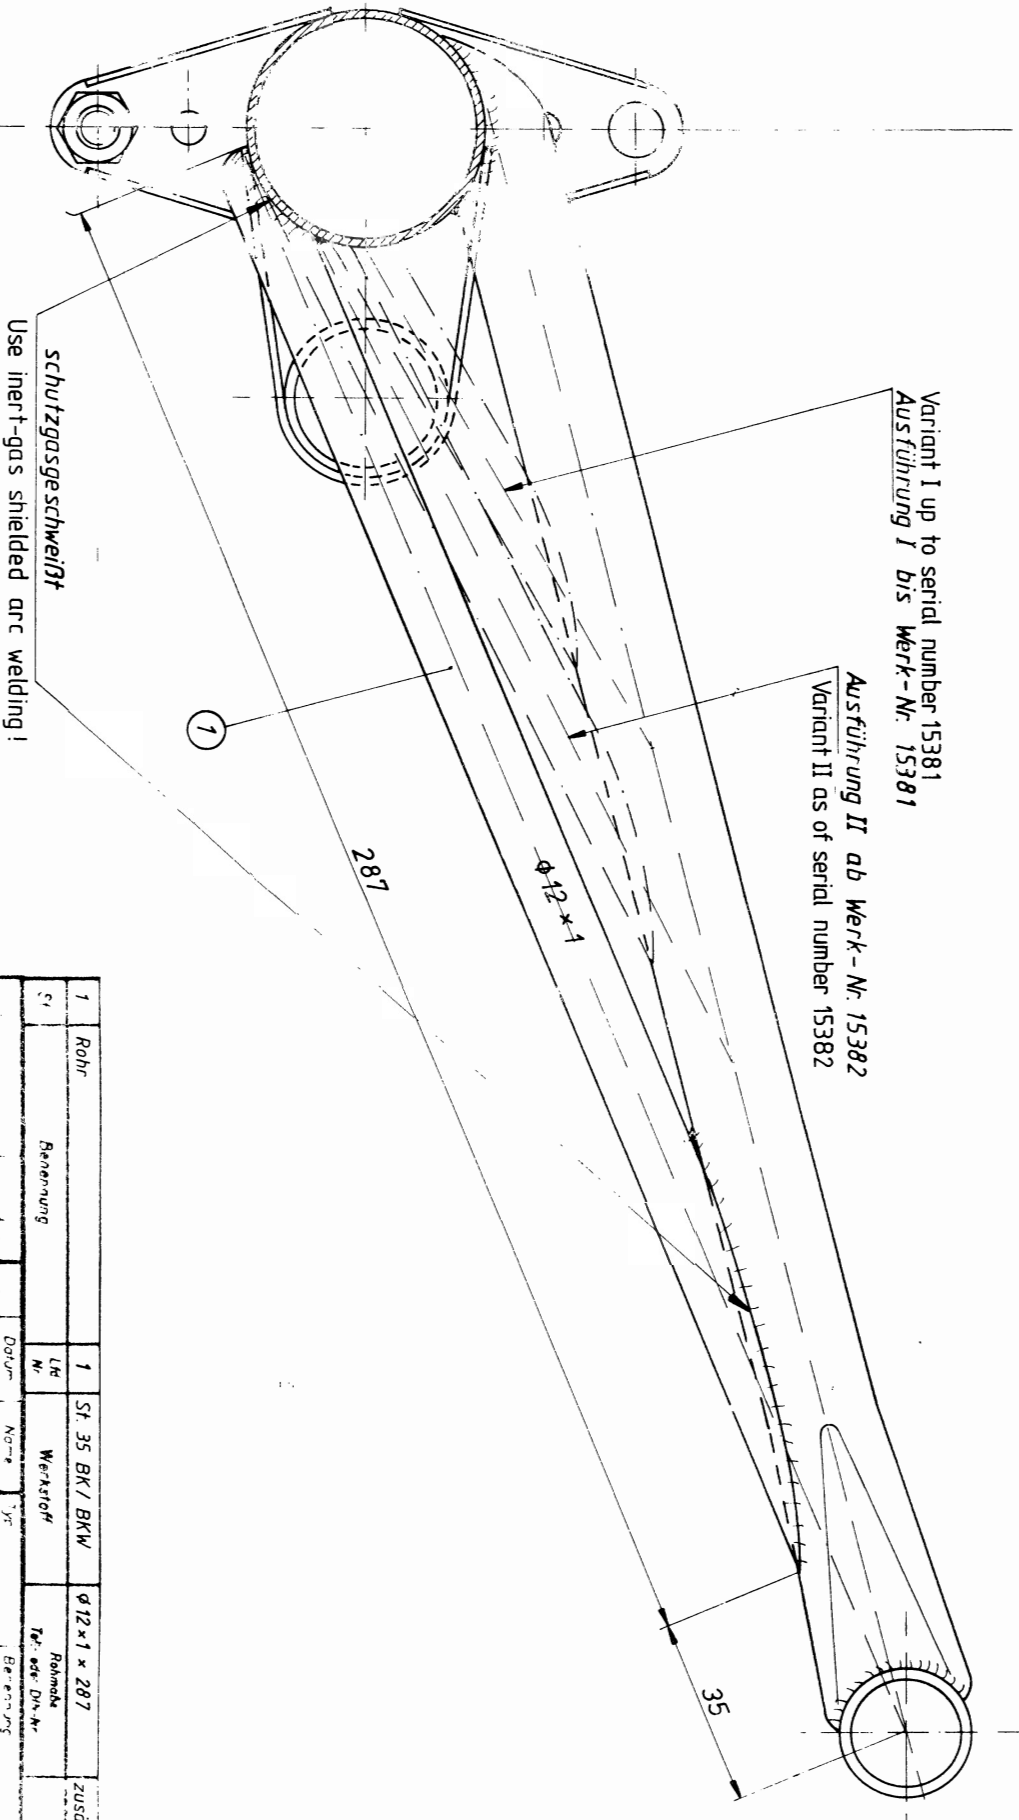
Drawing sheet no. 7
 Number of sheets: 11

Reason : Further to Schleicher Technical Note no.21 and LBA AD-Note 81-265 the owner of an ASW 15 B found a fatigue crack on the elevator actuator bellcrank inside the fuselage. An expertise ordered by the LBA concludes that an already existing smaller crack has been overlooked during the first inspection according to TN no.21 (LBA AD-Note 81-265) and has been found only during a second inspection after another 172 take offs when already 35 % of the cross area were cracked.

The elevator actuator bellcrank itself must be reinforced by an additionally installed tube ($\emptyset 12 \times 1$; steel St35BK or BKW) according to drawing sheet 151.35.1011 Ausführung IV (version IV). To do this properly, the paint has to be removed carefully at the welds (e.g. by sandblasting).

To guarantee minimum welding deformation (shrinkage) inert-gas shielded arc welding by use of 1.7324.0 welding wire must be applied. The ball bearing at the low end of the bellcrank needs not to be removed and a readjustment of the elevator control circuit is usually not necessary.

For this TN the drawing no.151.35.1011 "Ausführung IV" (version IV) has been made (see drawing sheet no.7 of this TN).
