Subject: Inspection and interior preservation of the wing spar.

Serial number applicability: All ASW 15 and 15 B,
including all conversions into motor gliders.

ALEXANDER SCHLEICHER
GmbH & Co.

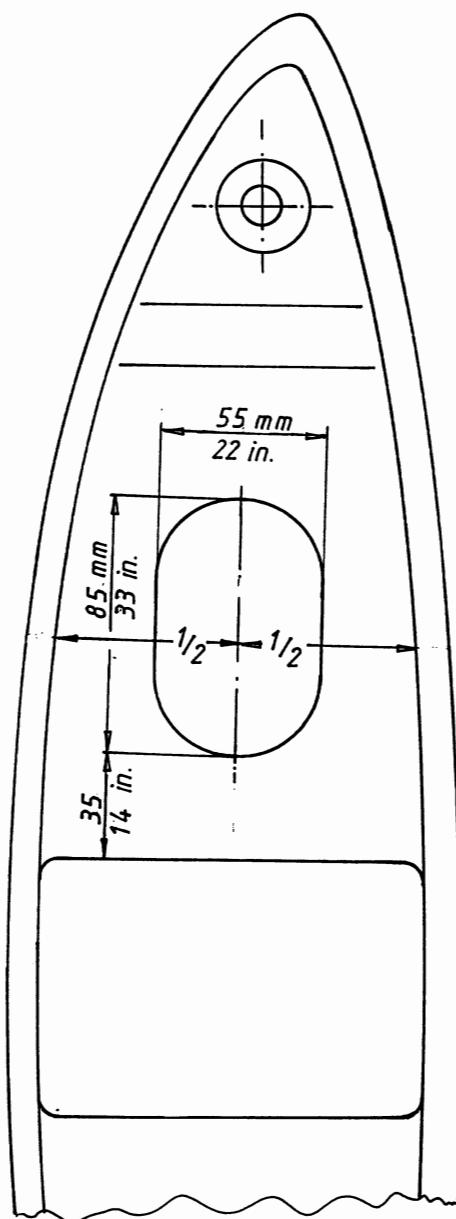
Only required for ASW 15s up to the serial no. 15183 !

- 1.1 The wing spar must be visually inspected for penetrated moisture, mould fungi and/or swelling up !
Mould fungi attack shows as discoloration of the wood into blue, brown or grey hues or as white mold fungi in lumpy shape or in cobweb-shaped, but irregular threads.
- 1.2 For this job you have to drill a hole through the opening in the root rib for the waterballast, using a drill of about 200 mm length (diameter according to the thickness of the endoscope). The endoscope with which the inspection of the spar inside can be done, has to be inserted into this hole (see Fig. 2). With ASW 15 gliders up to the serial no. 15183 there is no opening in the front root rib which, therefore, must first be drilled in this location (see Fig. 1). If you do not have an endoscope available, you can alternatively drill an opening of ø 28 mm.

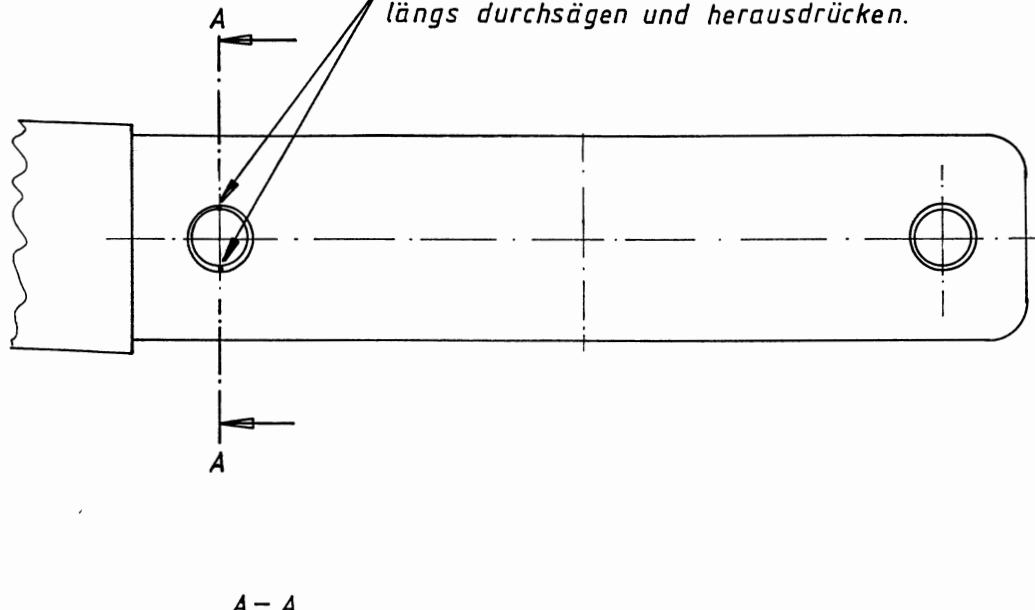
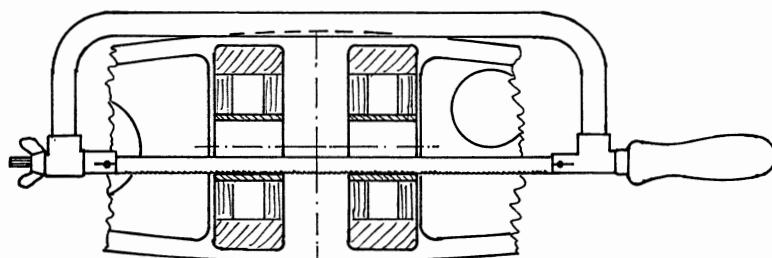
* Removal of the bushings

3. If a swelling up is clearly visible or if there is suspicion that water has penetrated into the spar fork or into the spar stub, the main pin bushings must be removed and the interior between the bushings must be inspected (see Fig. 7).
Normally the main pin bushings are level with the main spar winding or lie slightly back respectively.

Carefully saw through the bushings (at the top and at the bottom) in the longitudinal sense and then press them out!
