Subject: Adjustment of the water ballast actuation inside the fuselage

Serial number applicability: All ASW 27

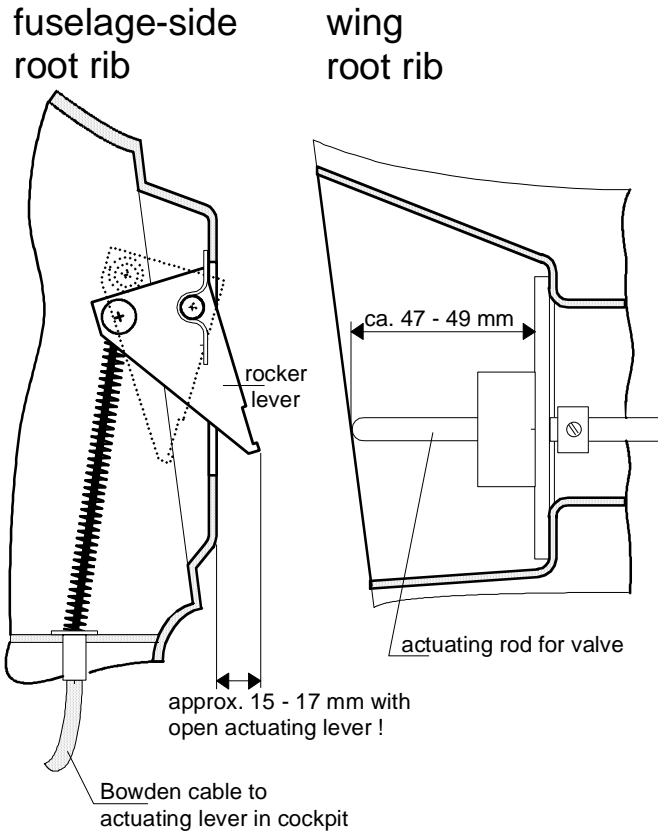
Fig. 1

Reason: In case that the water ballast valves in the wings drain uneven or do not open fully, their actuation may be checked and adjusted according to the following instructions. Badly adjusted actuation systems may be the cause that the rocker switch in the fuselage runs over the actuating push rod during rigging and so the valve inside the wing cannot open. In order to facilitate adjustment, the new version 2 uses the adjusting means at the rocker switch fitted at the fuselage-side root rib (and no longer at the front counter bearing of the Bowden cable, at the right under the seat pan support surface - previous version 1).

Action: Version 1:
As shown in Fig. 1, the correct adjustment of the valve actuation can be checked easily. The adjustment of the actuation system is done by turning in or out the adjusting screw at the front Bowden cable counter bearing (see Fig. 2). If the adjustment at the threaded bolt is not sufficient, the Bowden cable itself can be adjusted in length at the screw clamp (see Fig. 2.) Note that the cable is soft soldered into that clamp!

Version 2:
As shown in Fig. 1, the correct adjustment of the valve actuation can be checked easily. The adjustment of the actuation system is done at the rocker switch by turning in or out the lock nut at the threaded connector of the Bowden cable (see Fig. 3).
