Subject: Adjustment of the water ballast actuation inside the fuselage
Serial number applicability: All ASW 28

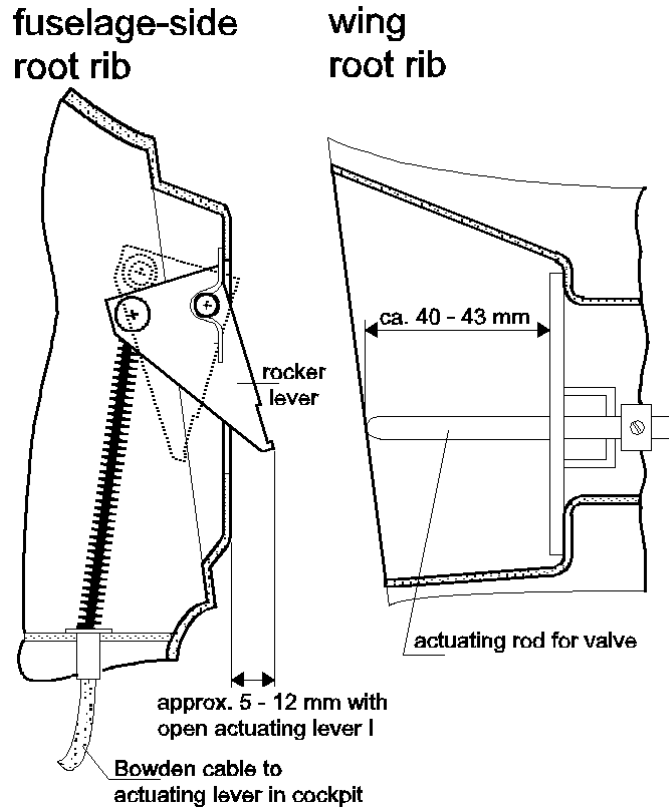
Fig. 1

Reason: In case that the water ballast valves in the wings drain uneven or do not open fully, their actuation may be checked and adjusted according to the following instructions.
Badly adjusted actuation systems may be the cause that the rocker switch in the fuselage misses the actuating push rod by running over it during rigging and so the valve inside the wing cannot open.

Action: As shown in Fig. 1, the correct adjustment of the valve actuation can be easily checked.
The adjustment of the actuation system is done at the rocker switch by turning the lock nut at the threaded connector into or out of the Bowden cable (see Fig. 2).
