Subject: Adjustment of the actuation system for the water ballast valves.

Applicability: EASA.A.0220, all ASW 27-18 and ASW 27-18E

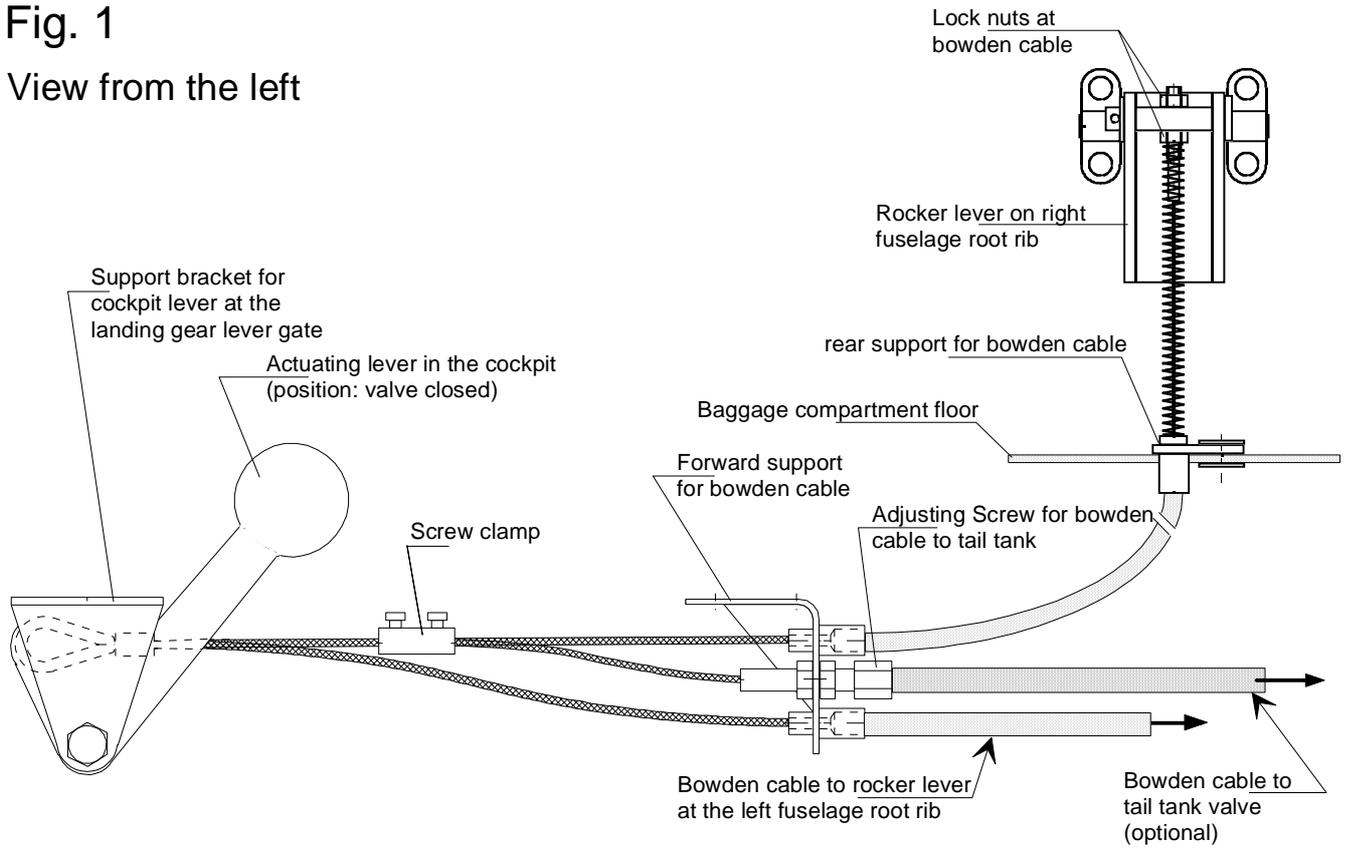
Fig. 1
View from the left

Action: For an equal operation of the water ballast valves, the bowden cables of the system can be adjusted at different positions (Fig. 1). They are to be adjusted in the following manner:

Wing water ballast: The rocker levers at the fuselage root ribs incorporate a stop preventing them from rotating too far out of the fuselage. In the "valve open"-position the rocker levers rotate nearly up to the stop. The adjustment is made directly at the rocker levers, namely at the threaded brass end of the bowden cable.

Tail tank / Fuselage tank (if installed): The bowden cables are adjusted such, that they are just relieved in "valve closed" position. They can be adjusted at the forward support behind the cockpit lever (also see Fig. 2.4-6 in the Maintenance Manual).
