**Subject:** Repair of the tailcone by scarfing

**Applicability:** EASA.A.0220, all ASW 27-18 and ASW 27-18E

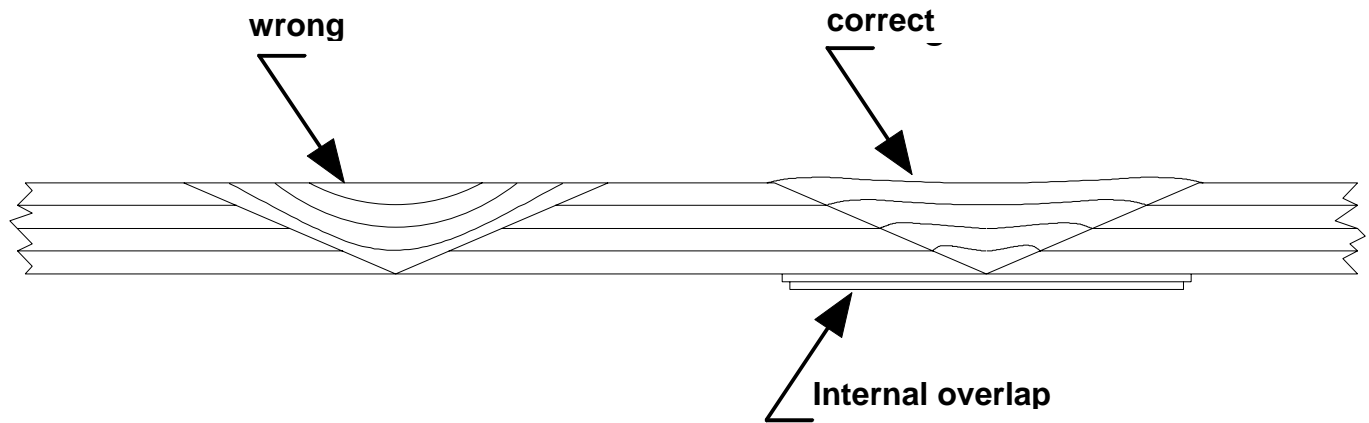
**Reason:** For the repair of the ASW 27-18 tailcone skin it is important that the hybrid laminate of the skins is preserved.

This means that after the repair the arrangement of the layers (from inside to outside) still corresponds to the original layer scheme, ie. the sequence of layers is maintained: glas-, carbon, kevlar, core material U-Pica-Mat (not scarved but adjoined bluntly), carbon, glas

- Action:**
0. Make a „backbone“ jig by use of an unbroken ASW 27 fuselage.
  1. Trim edges of broken tailcone in straight lines.
  2. Prepare an internal overlap (2x 92140 diagonal and 1x 92110 longitudinal, about 180 to 200mm long) and glue approximately 50% into the wider part of the fuselage.
  3. Adjust the other part on the rig and glue both parts together.
  4. Prepare scarf joints and scarf joint lengths according to Repair Manual

5. U-Pica Mat (Layer 19) is removed as a step.

6. The innermost layer of 92110 (Layer 25) is already replaced by the internal overlap and need no action any more
7. Laminate one layer CCC Style 763 longitudinal (Layer 22), scarf length approx. 16,5 mm long and overlap over corresponding scarf.

- 8a. In the area, where no core material was present (i.e. more than 2.5m behind the landing gear doors): Laminate one layer of 03040 diagonal (Layer 20) and overlap over corresponding scarf.

- 8b. In the area where core material was present, replace U-Pica-Mat without overlap. Now wind peel ply around the repaired area. Remove peel ply after hardening and check for air bubbles in the U-pica-Mat.

9. Laminate one layer 98608 diagonal (Layer 18) and overlap over corresponding scarf.
10. Laminate one layer 03056 diagonal (Layer 16) and overlap over corresponding scarf.

11. Laminate one layer CCC Style 796 longitudinal (Layer 11) and overlap over corresponding scarf.
12. Laminate one Layer 92145 longitudinal (Layer 4). Now wind peel ply all around and make bondage with tape to press for low resin content and harden and post cure. Remove peel ply after hardening and only scarf layer 92145, fill and gelcoat.
