# MANDATORY SERVICE BULLETIN

## NO. MSB-AE50R-002

Fixation of the grub screws in the generator rotor assembly.

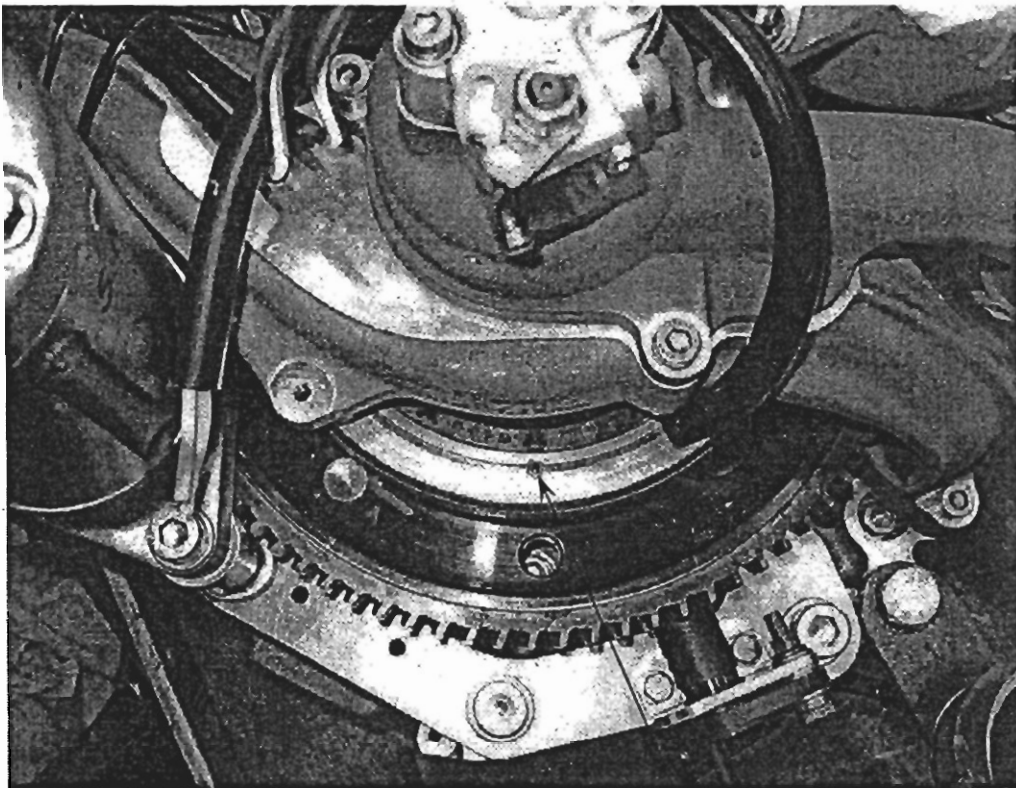
Normally the grub screws are fixed with LOCTITE 648. Due to a production error this fixation is missing in a few generator rotor assemblies. Thus it is possible that these screws become loose.

- Remove all three grub screws in the generator rotor assembly (see Pos 1 in the following picture)
- Clean the grub screws and the tapped holes with ACETON.
- Screw in the grub screws and paste them into the holes using LOCTITE 648
- Clean the working area
