Removing play between the sockets and bolts of the wing-fuselage transition

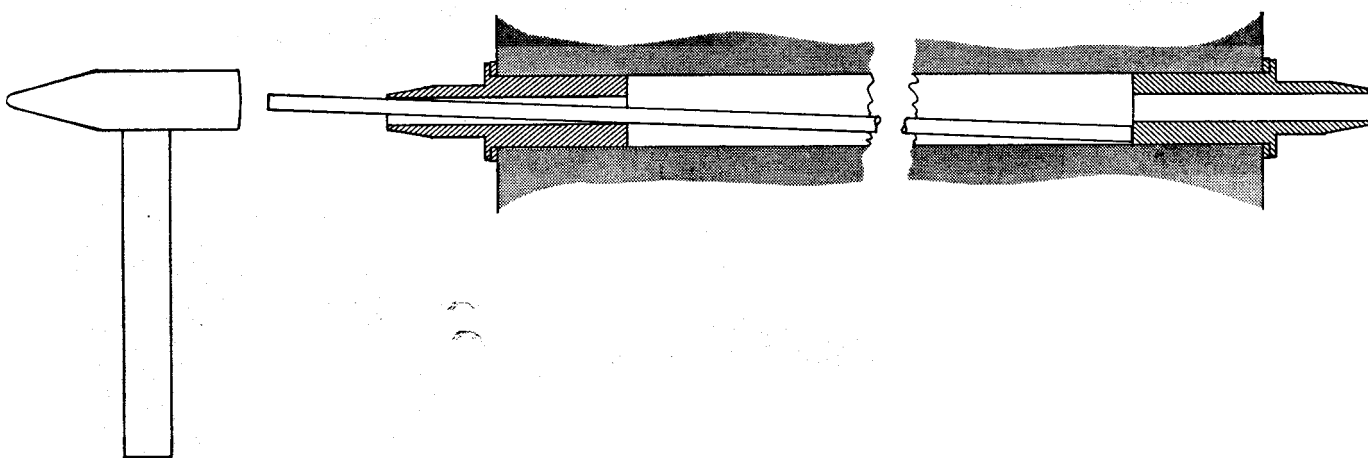
3. The bolts are slid out of the fuselage cross tubes by fitting a steel rod through the hole in the opposite bolt, and driving the bolt out from the inside with a hammer (see sketch below).

4. After fitting the metal washer(s), it should be possible to drive the bolt back in place, using only a 500 g (~ 1 lb) hammer and a few blows. If it returns too easily, then knurl the seating area slightly until a tight fit is obtained again.
