**Subject:** Improvement of the performance map of the new IAE50R-AA ECU with serial numbers "AE00XXX" which were installed as standard from 2014 onwards.

<b>ASK 21 Mi</b>	Type-Certificate EASA.A.221	all serial numbers
<b>ASH 25 Mi</b>	Type-Certificate EASA.A.213	all serial numbers
<b>ASH 30 Mi</b>	Type-Certificate EASA.A.213	all serial numbers
<b>ASG 32 Mi</b>	Type-Certificate EASA.A.599	all serial numbers

This Technical Note bases on a change, which was approved by EASA under the minor change approval EASA 10063416.

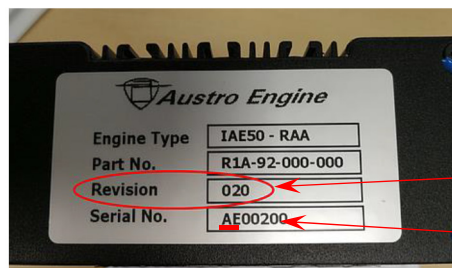
**Fig. 1: Affected ECU version**

Only aircraft with ECU serial number beginning with AE and revision 020 or AA1 are affected, see also "Reason".

The revision is 020 (or even AA1)

The serial number starts with AE

**Action:** Send the removed ECU to A. Schleicher GmbH or Austro Engine to upload the new software with the version number "SW\_V1.1.9.2.4". The company A. Schleicher GmbH has the possibility to upload the software even when the ECU is installed. Customers in the USA or Australia may contact the local representatives of A. Schleicher GmbH.

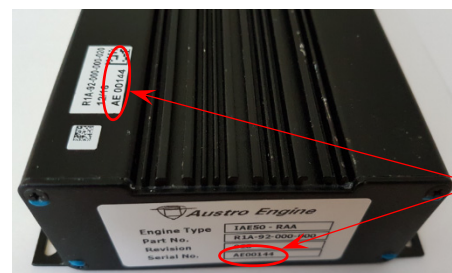
**Fig. 3: Identification of the ECU at ASH 30 Mi und ASG 32 Mi.**

When installed the serial number of the affected ECU's can be checked on the upper label too.

It takes some effort to remove and reinstall the ECU. For identification of the ECU's serial number, it is also possible to use the label that is visible when installed, see Fig. 3. If the ECU is reprogrammed in the installed state and the revision of the ECU's identification plate is not accessible, an alternative replacement plate (see Fig. 4) is attached to the accessible side of the ECU. If this ECU is removed or replaced later, this replacement plate has to be removed and the revision changed on the original identification plate as described above.
