Removing play between the sockets and bolts of the wing-fuselage transition

Alexander Schleicher
GmbH & Co.

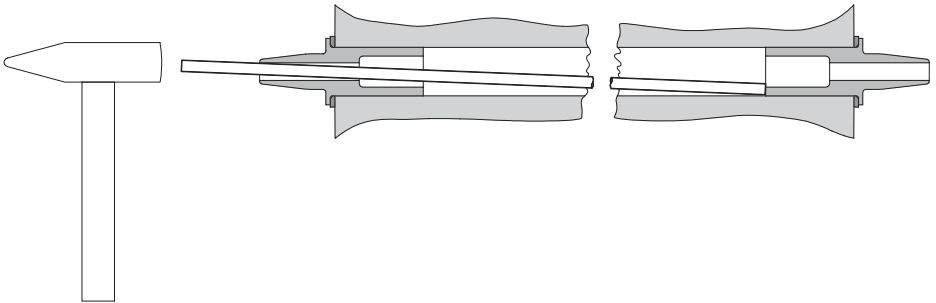
1. Longitudinal play between the four sockets in the wings and the bolts on the fuselage (Note: for the ASK 21, only the socket/bolt connection front in the wing nose/fuselage transition) leads to disturbing click-click noises when the rudder is operated, and can result in unpleasant tail oscillations at high speeds.
2. The play is eliminated by fitting metal washers of $\text{Ø}22.5/32$ - thickness according to the extent of the play. By testing, the play must be reduced such that the wings can be assembled still properly - this applies to a normal temperature of 20°C .

Depending on the extent of the play, the metal washers can be fitted under one or more bolts.

3. The bolts are slid out of the fuselage cross tubes by fitting a steel rod through the hole in the opposite bolt, and driving the bolt out from the inside with a hammer (see sketch below).
4. After fitting the metal washer(s), it should be possible to drive the bolt back in place, using only a 500 g (≈ 1 lb) hammer and a few blows. If it returns too easily, then knurl the seating area slightly until a tight fit is obtained again.
