Technical NoteNo. 41Technical NoteNo. 15

Subject: Applicability:	Cracks in the bonding of the wing root rib ASK 21; Type-Certificate EASA.A.221 Models ASK 21 and ASK 21 Mi ; all serial numbers	
Classification:	Major Change	
Urgency:	Action 1 "Inspection for Cracks" until 31.12.2019 at the latest, afterwards annual Actions 2 and 3 if necessary	
Reason:	Inspection for cracks in the bonding of spar and wing shell (in the area of the root rib), resp. root rib and repair of the bonding, if necessary	
Action:	1. Inspection for Cracks	
	Cracks might occur at the following locations in the bon	ding joints:
	<image/>	At the edge between root rib, spar and wing shell In the bonding joint between root rib and spar Photo example: Root rib ASK 21 B, left wing, spar fork. The accompanying illustration is also valid for the right wing (spar stub).

No. 41 No. 15 Alexander Schleicher GmbH & Co. Segelflugzeugbau D - 36163 Poppenhausen

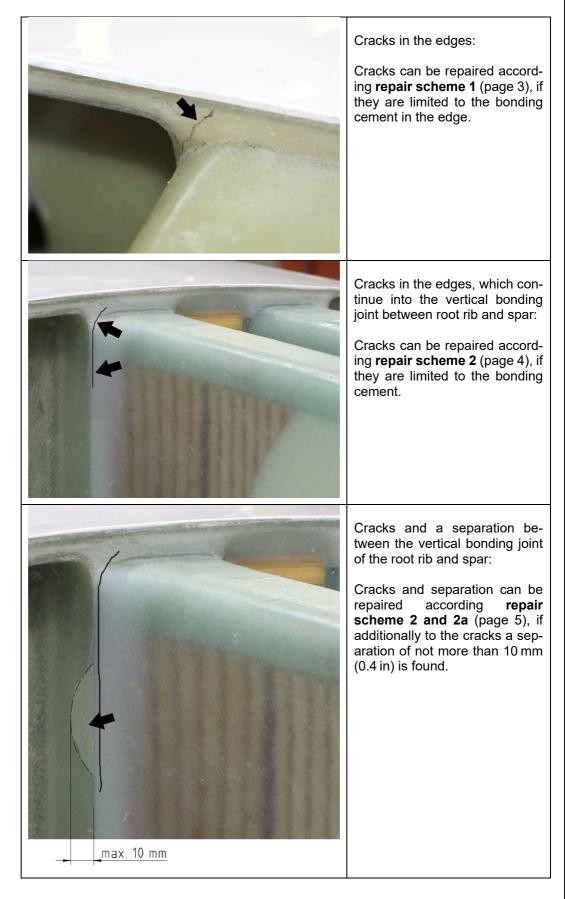
2. Crack Assessment

White markings (delamination) in the structural parts (root rib, shell, spar) and debondings, found by ping testing of the bonding joints, indicate a bigger damage, causing an appropriate bigger repair according TN 02-2005.

The same applies for cracks, which continue deeper than the stated above 10 mm (0.4 in) or even until the rear side of the bonding joint of the root rib. These are signs of structural overloads and are not comparable to the cracks described in this technical note.

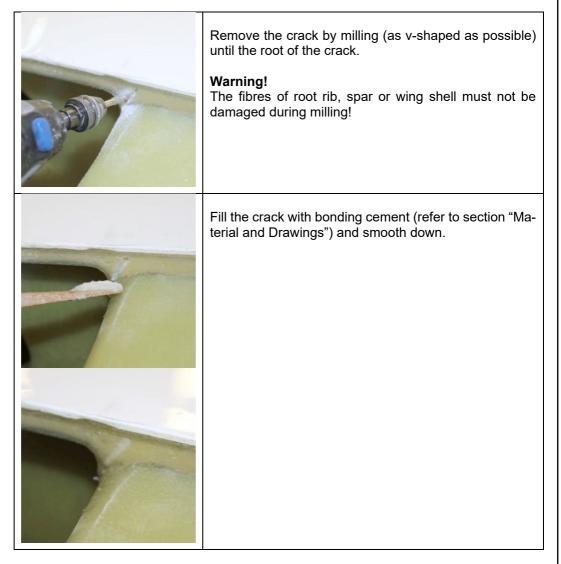
Repair Scheme 1

for cracks in the edges

Anneal the repair after finishing according to repair manual min. 12h at 55°C (131°F).

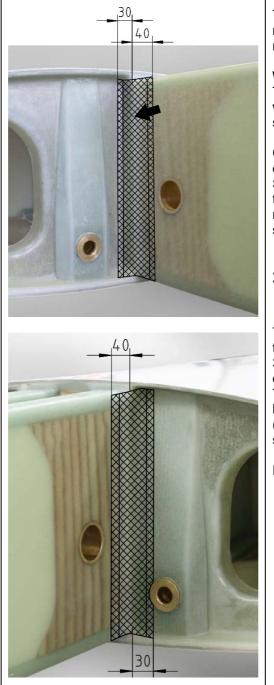
Repair Scheme 2

Cracks also in the vertical bonding joint

The cracked bonding cement has to be removed resp. v-shaped milled to the crack root.

The fibres of root rib, spar (especially the winding outside of the spar) or the wing shell must not be damaged.

Clean the area thoroughly (especially from oil or grease) and roughen the surface. Smooth the step from the root rib flange to the spar with a \sim 30° ramp of bonding cement and apply the following laminate scheme:

2 Plies 92140 diagonal

alternatively 2 Plies 92130 diagonal

The first ply is applied 40 mm (1.6 in) from the edge of the root rib onto the spar and 30mm (1.2 in) from the edge of the root rib onto the root rib.

The second ply is applied the same way, but 10 mm (0.4 in) shorter on each side (stepped). It is also possible to apply the shorter ply at first.

Finally apply peel ply.

Anneal the repair after finishing according to repair manual min. 12h at 55°C (131°F).

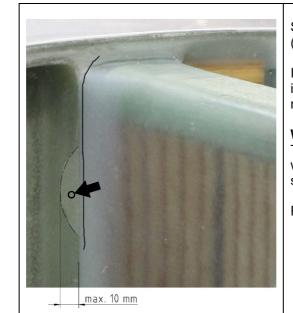
Repair Scheme 2a

Separation in the vertical bonding joint

Separations, **not** deeper than 10 mm (0.4 in), can be repaired as follows:

Inject resin with a syringe via a small drilling (< 1.5 mm / 0.06 in) near the end of the root rib into the separated area.

The fibres of root rib, spar (especially the winding outside of the spar) or the wing shell must not be damaged.

Further repair as per **repair scheme 2**.

Anneal the repair after finishing according to repair manual min. 12h at 55°C (131°F).
