**Subject:** Checking the free movement of the front rudder pedals

**Applicability:** **ASK 21 B**; Type-Certificate EASA.A.221; serial numbers 21953 – 21969 (S/N 21955 not affected)

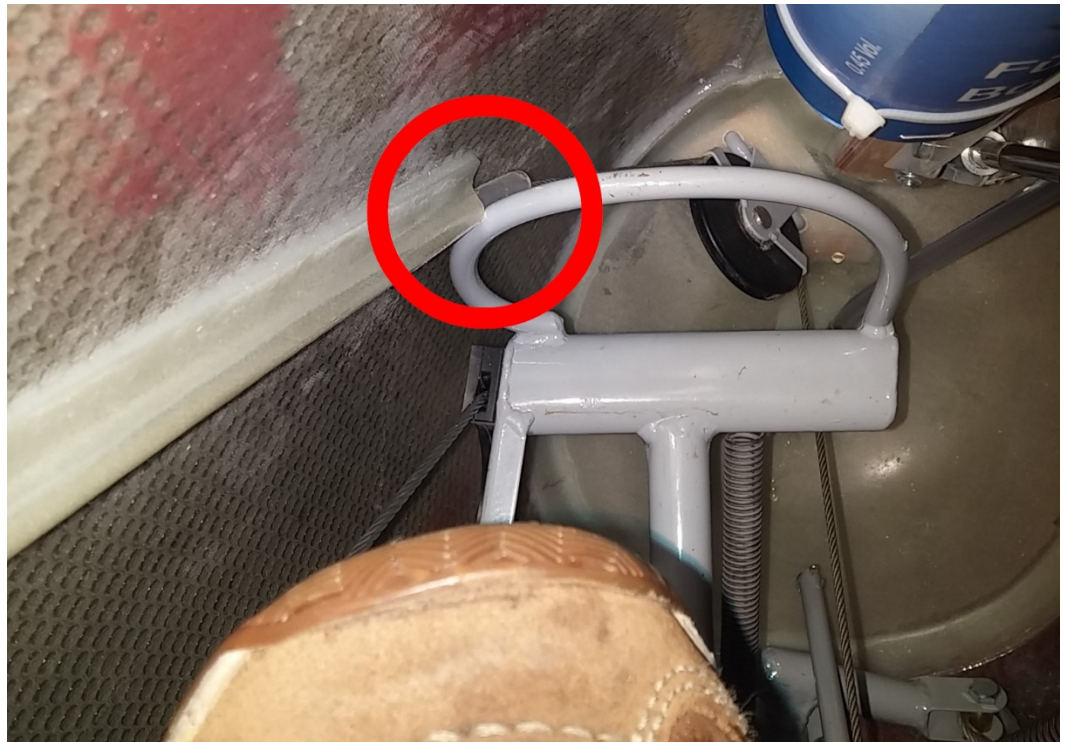
**Reason:** In one case the left rudder pedal in the front seat jammed during full actuation due to manufacturing tolerances. It cannot be excluded, that other aircraft of the ASK 21 B series are also affected.

The left rudder pedal might interfere with the cable guide of the release mechanism and jam under applied load, especially in the foremost pedal positions and left rudder deflection, see figure 1. There should be at least 4 mm (0.16 in) space between the pedal and the cable guide in all possible positions / deflections of the left rudder pedal. Is this not the case, one of the actions described in point B) have to be accomplished.

Fig. 1: Possible jamming of the rudder pedal with the cable guide of the release mechanism cable

**B1)** Blocking of the foremost pedal positions

The jamming occurs only in the foremost positions of the rudder pedals. These can be blocked, so that the rudder pedals cannot be adjusted to the foremost pedal positions any more. Block so many positions until the clearance according action A is secured. The following can be done for blocking: Insert a proper sized rivet (e.g. DIN 7337 Ø 6.4 mm) in the last free locking hole in front of the new pedal end position. Now the pedals cannot be adjusted more forward than the blocking.

B2) Shortening and Chamfering of the cable guide

The glass fibre part, which holds the white plastic tube in position, can be shortened by max. 50 mm (2 in). Further the front end of this fibre part can be chamfered. Now the clearance according action A must be restored again.

B3) Moving of the cable guide

The whole cable guide of the release mechanism can be moved upwards by max. 30 mm (1.2 in), so that the clearance according action A is restored again. Watch for a flawless routing of the release mechanism cable. If the inner layers of the fuselage shell should be damaged during moving of the cable guide, they have to be repaired.
