Effective for ASW 15B since serial number 15357

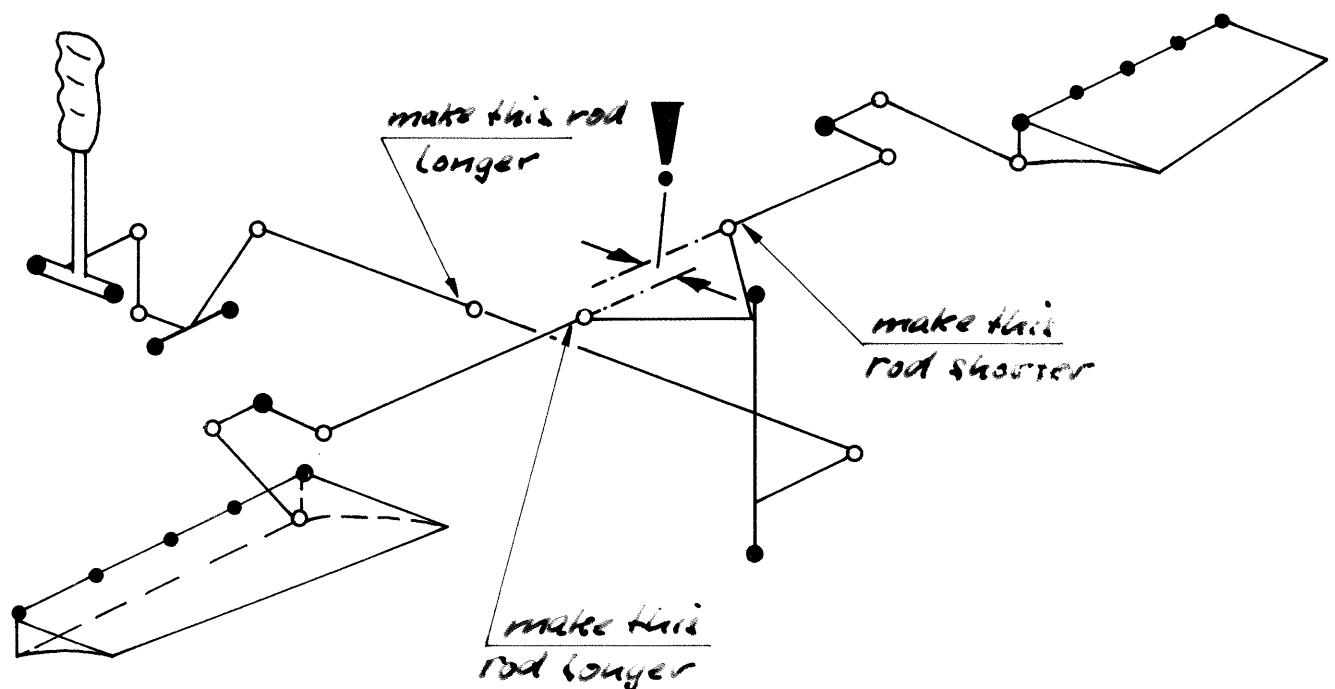
- 1) Glider makes a right turn, stick free.
- 2) In level flight increasing stickforce to the left must be applied with increasing speed.

Installation of aileron control bellcrank in the fuselage non symmetric.

Push pull rods of the wings must be corrected according to sketch below; after test flight stick must be corrected to zero position in fuselage (below baggage compartment).
