Subject: Inspection of the screw lock at the automatic connection of the airbrake control system

Applicability: **ASK 21 B**; Type Certificate EASA.A.221; serial numbers 21953 – 21982 (S/N 21955 not affected)

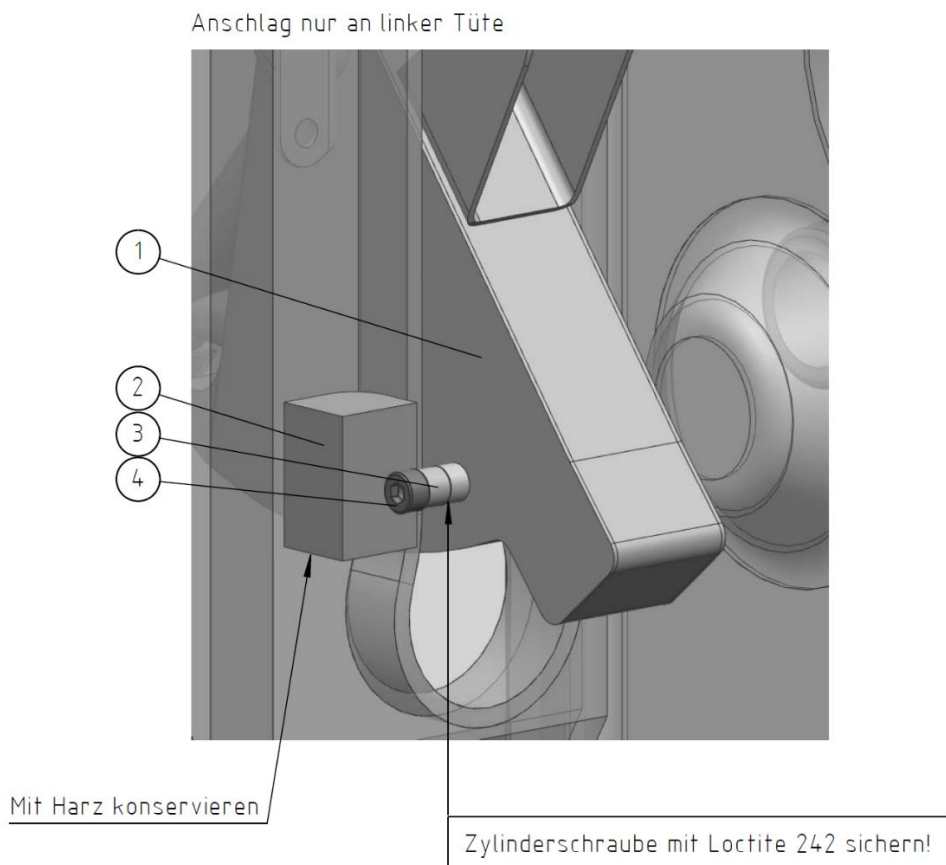
Reason: A socket head screw M5x10 was found in one case in the fuselage of an ASK 21 B during pre-flight inspection. Investigations have shown that this screw was initially mounted at the automatic connection of the airbrake control system at the left wing-to-fuselage junction. Loosening of this screw was caused by a missing screw lock. It cannot be excluded that other aircrafts of the ASK 21 B series are affected, too.

The cone (pos. 1) of the automatic connection of the airbrake control system at the left wing-to-fuselage junction is equipped with a stop which prevents overcentre locking when the aircraft is de-rigged. The stop is realised by a DIN912-M5x10 socket head screw (pos. 4) which is screwed into the lateral wall of the cone by the use of an additional brass-bushing (pos. 3). The counterpart is a plywood block (pos. 2) which is glued on the inner side of the fuselage root rib. It must be checked that the screw and the brass bushing are in place. If both parts are present, unscrew the screw and insert it again secured with Loctite 242. If the screw and bushing are missing than the complete fuselage must be checked for these parts. Only when it is ensured that these parts are not in the fuselage than the stop can be reinstalled using a new screw and bushing. Secure the screw using Loctite 242.

Fig. 1: Stop at the left automatic connection of the airbrake control system

The plywood block at the root rib must be protected against moisture using epoxy resin coating.
