Subject: Inspection of the root ribs at the wings for damages

Applicability: **ASW 15**; Type-Certificate LBA 272; model ASW 15, serial numbers 15001 up to 15183 (Unless all root ribs have been replaced by new parts from the ASW 15B according action C of the TN 29)

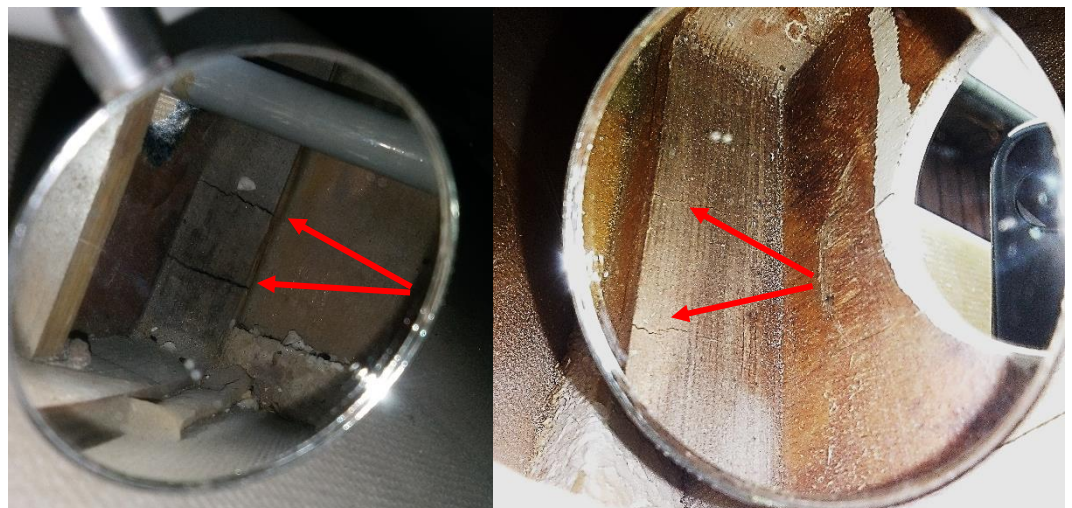
- a) Cracks perpendicular to the root rib plane at the wider flanges of the rib (see Fig. 1)
- b) Cracks perpendicular to the root rib plane through the reinforcement around the fit pin bushings (see Fig. 2)
- c) Cracks parallel to the root rib plane at the wider flanges of the rib (see Fig. 3)
- d) Cracks in the shear wall of the rib, especially in the area around the cut-outs (see Fig. 4)
- e) Loosening of the rib from the spar of the wing shell (see Fig. 5)
- f) Loose lift pin bushings (see Fig. 6)

Fig. 1: Cracks perpendicular to the root rib plane. Left: significant cracks, right: incipient cracks

Notes: For the exchange of damaged root ribs the repair instruction of TN 29 has to be regarded.

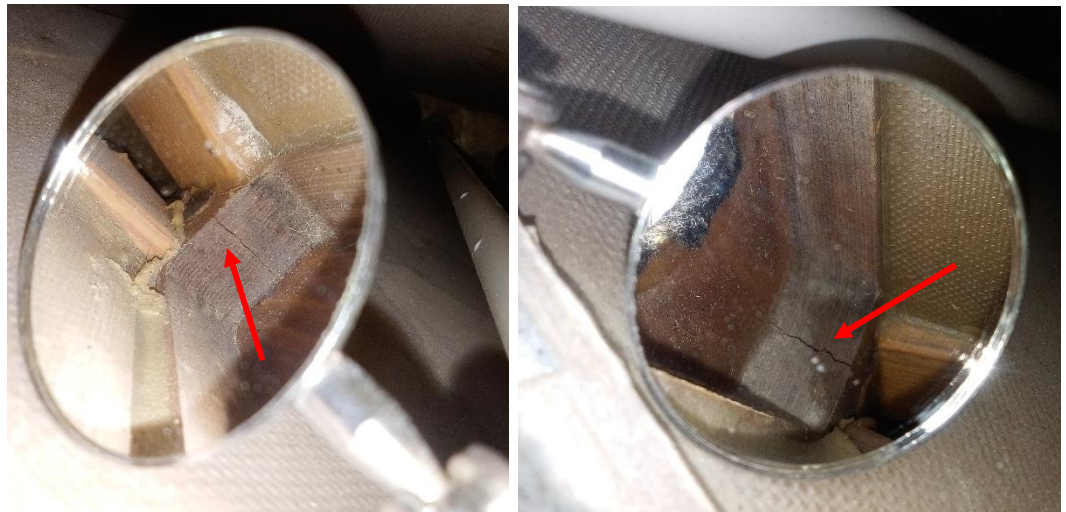
Fig. 2: Cracks through the reinforcement around the fit pin bushings

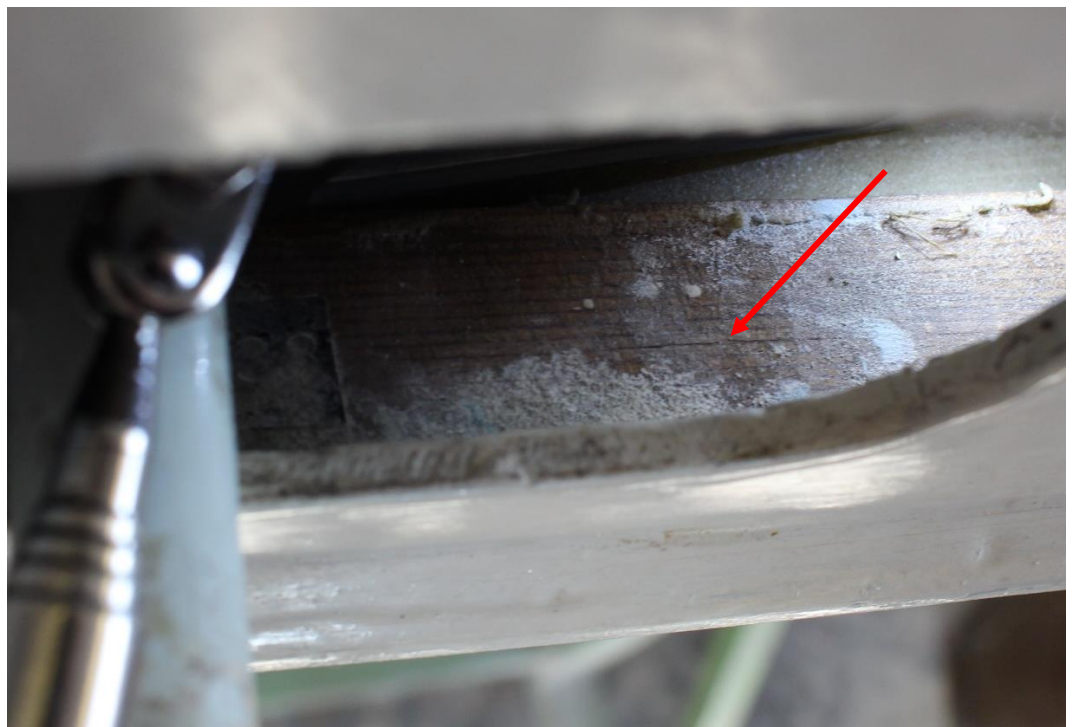
Fig. 3: Cracks parallel to the root rib plane

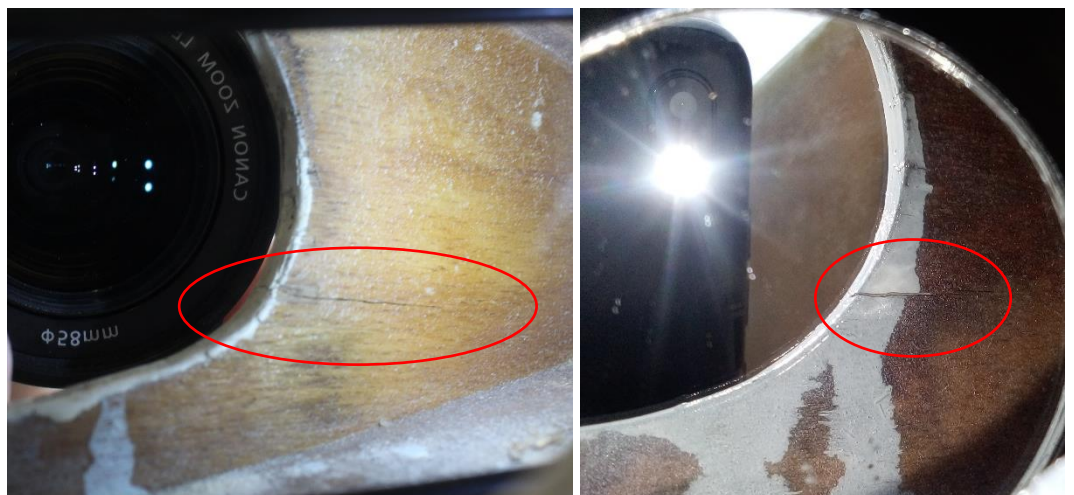
Fig. 4: Cracks in the shear wall

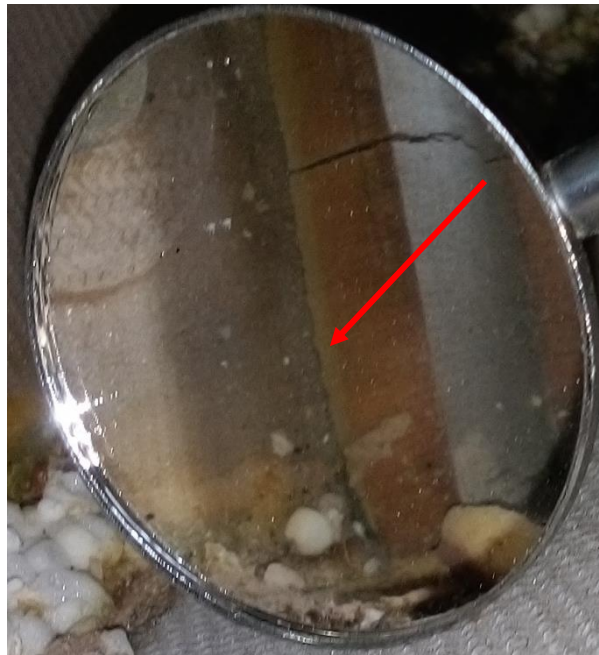
Fig. 5: Loosening of the rib from the spar

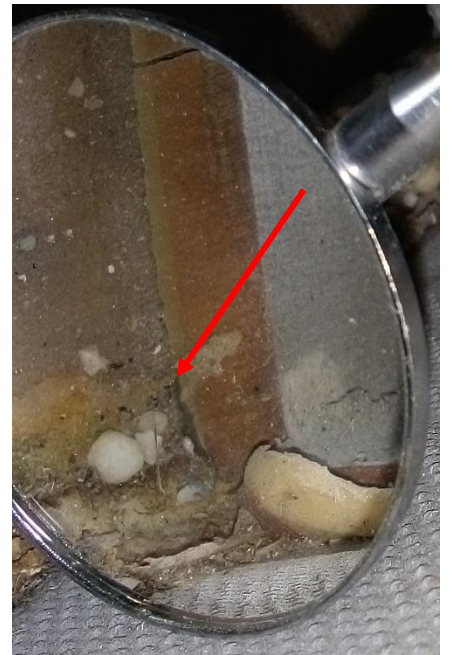
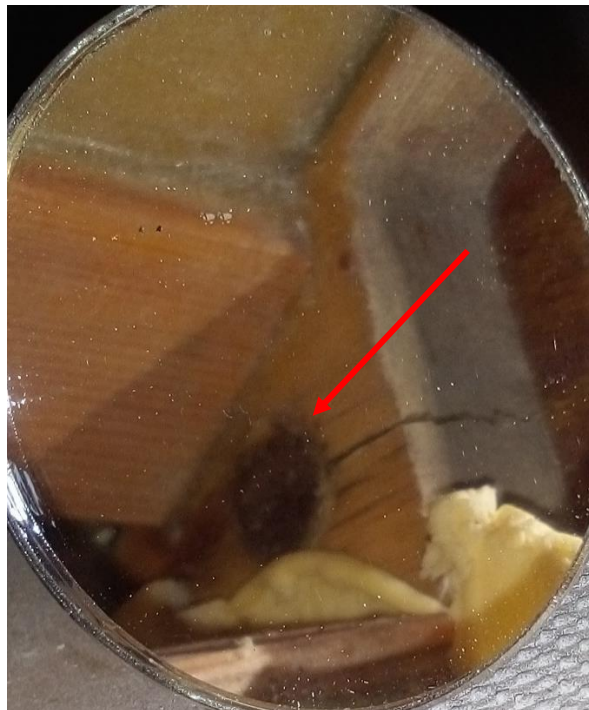
Fig. 6: Loose lift pin bushings
