Flight Manual

The present appendix 01-2021 gives additional information, instructions and limitations to the original Flight and Operating Manual. The appendix has the same validity as the basic manual. All limitations and information given in this appendix must be fully regarded by the crew and/or the owner of the aircraft.

Operating Manual

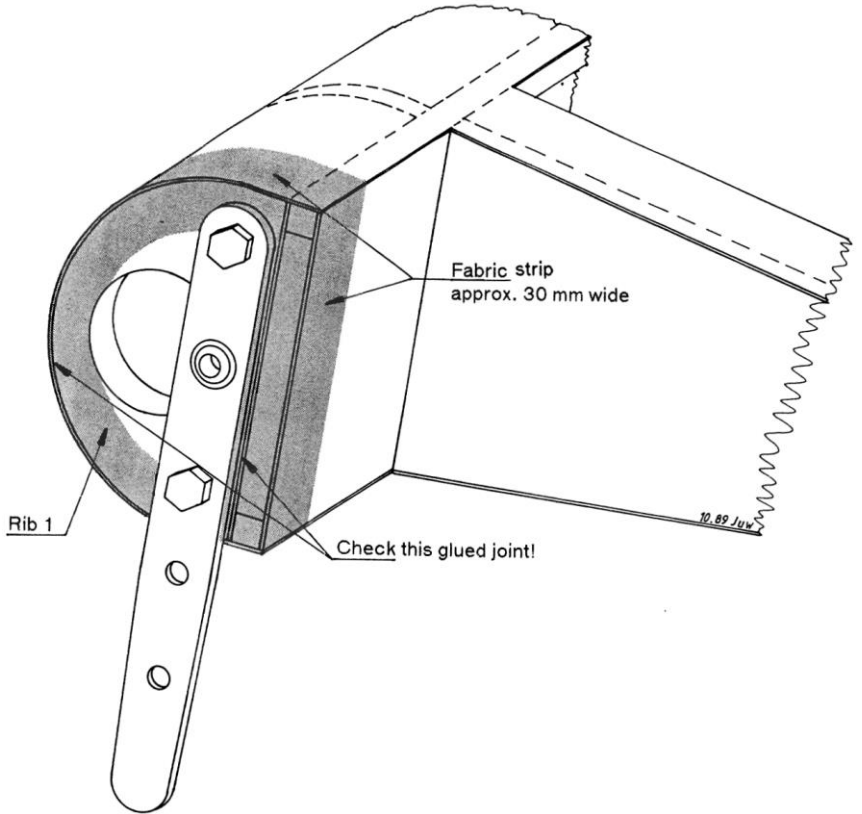
Fig. 3-1 Right half of the elevator

Failures of gluing attachment of the elevator due to aging or overloading have increasingly been found. Since this area is essential for the safety of the aircraft, the inspection must be carried out with great care.

4. Check that the glued joint between rib no. 1 and the plywood cover of the D-box or respectively the elevator spar is in good condition. By the use of a knife tip or a feeler gauge at the glued joint the tight fit of all parts can be checked. The inspection should also be carried out from the inside using a mirror or endoscope.

5. If no damage on the glued joint is found, the edge must be covered once again after the inspection with a fabric strip as shown in Fig. 3-1. Finally, apply weather and moisture protection (painting).
