ASW 19, L-308
ASW 20, L-314
Maintenance Instruction
H

Alexander Schleicher
Segelflugzeugbau
6416 Poppenhausen

Type: Instructions regarding maintenance and adjustment.

Subject: Adjusting the towhook after an unintentional release.

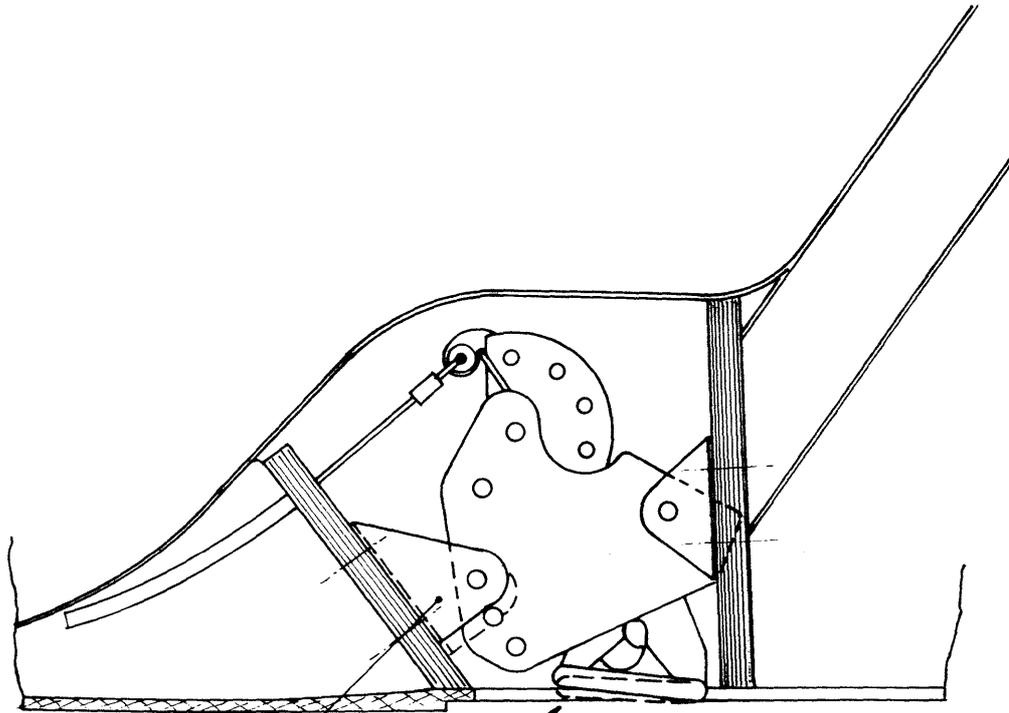
- a) The modification to the double ring pair (large ring oval) makes it possible for the second ring (which is now larger) to touch the structure surrounding the tow-hook end and, if the cable is twisted, it can then cause the automatic mechanism to unlatch.
The solution here is to relieve the structure which surrounds the towhook; this material is only a mudguard. The seam which supports the landing gear doors can also be shortened to about 5 mm (0,2 in) in front of the towhook.

Automatic ring almost parallel to outside contour.

New, modified towhook fitting.

- b) If the measures described in a) do not help, the forward towhook fitting can be modified. To do this it is usually necessary to make up a new fitting which is designed to suit the particular installation. In this case you must contact the manufacturer so that a new fitting can be manufactured.
Good results have been achieved with the new ring pair, if the towhook is sunk into the forward fitting far enough for the automatic towhook ring to run almost parallel to the outside contour (see accompanying sketch).

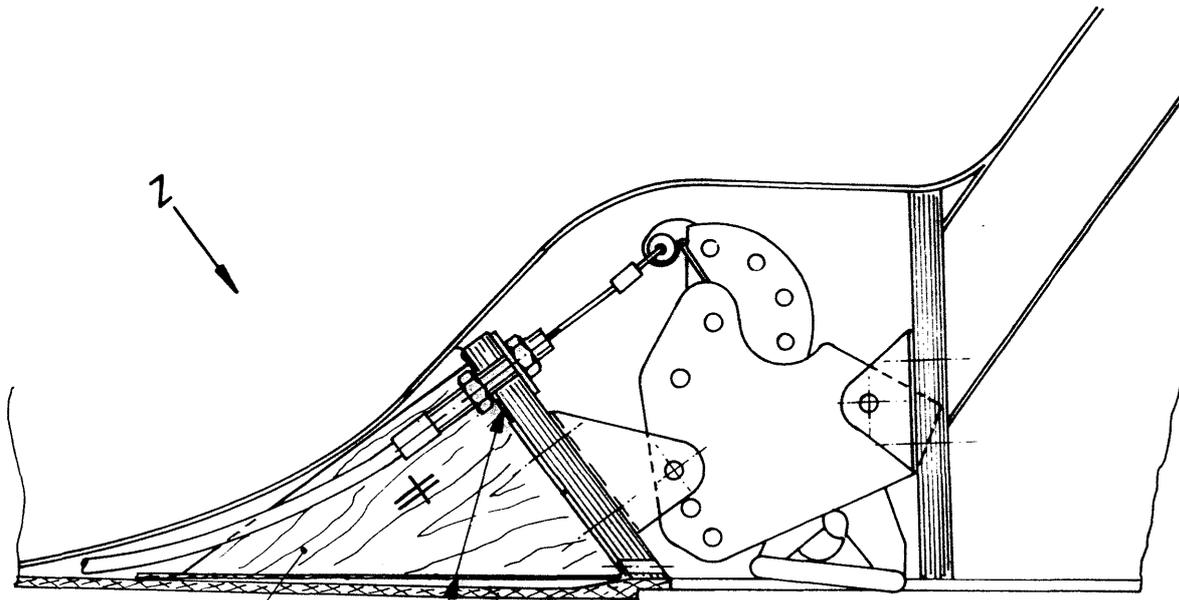
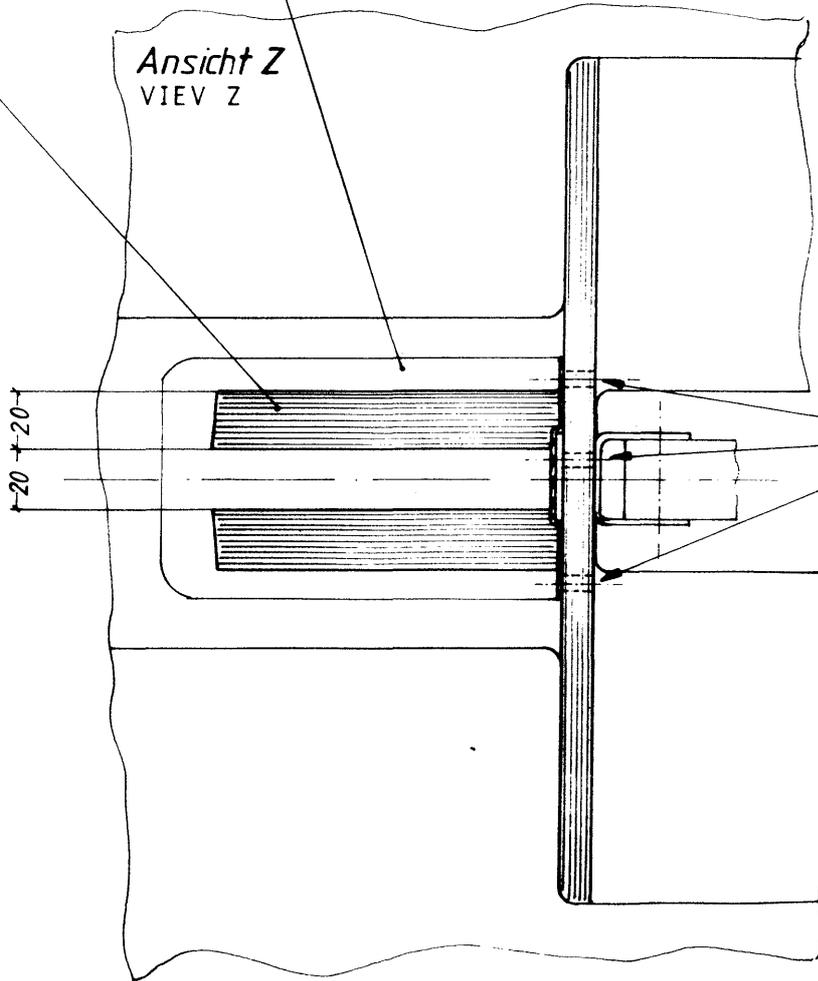
Ansicht Z
VIEV Z

- c) After a belly landing and/or if water has been allowed to stand in the cockpit for a long period, the glued joint between the rear towhook bulkhead and the fuselage shell may fail. This weakens the towhook installation to the point where the towhook may twist under a severe load (such as occurs during cable snatches); this movement may be enough to cause a stiff and/or too critically adjusted towhook cable to open the latch of the towhook (see pages 3 and 5 for more information). In this case the glued joint between towhook and bulkhead must be repaired. Clean up the glueing surface and fill the slot (e.g. made with a piercing saw blade) with a filler paste consisting of:

Reinforcement
Verstärkung
Sph. 6.1013. Plywood

2 Lagen 92140, beliebig
2 layers 92 140, any weave direction

Drainage holes ϕ 6 mm

- Drill a \emptyset 6mm (0,24 in) hole through the towhook bulkhead to allow water to drain away. Seal the hole thoroughly, using resin/hardener or paint !

A successful reinforcement to the forward towhook bulkhead of the C.G. towhook has proved to be two wedge-shaped plywood blocks (see sketch on Page 5). Two layers of glass cloth 92140 are laid over the joint surfaces of the blocks, with random fiber orientation, and resined together. Do not forget to preserve the water drainage holes.
