Subject: Exchange of wing root ribs

Applicability: **ASW 15**; Type-Certificate LBA 272; model ASW 15

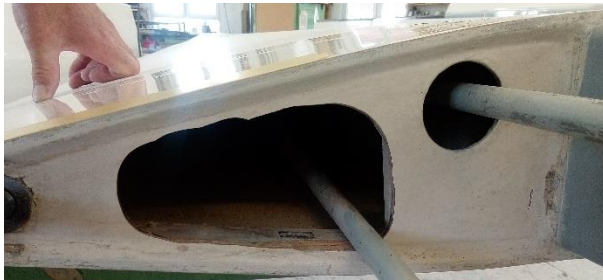
Starting removal of the wooden rib by milling starting from the opening of the aileron control rod.

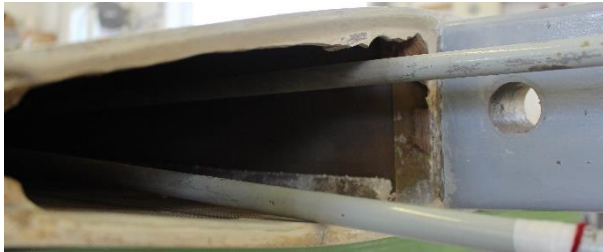
Wooden rib removed from the wing. The flanges are still in the wing.

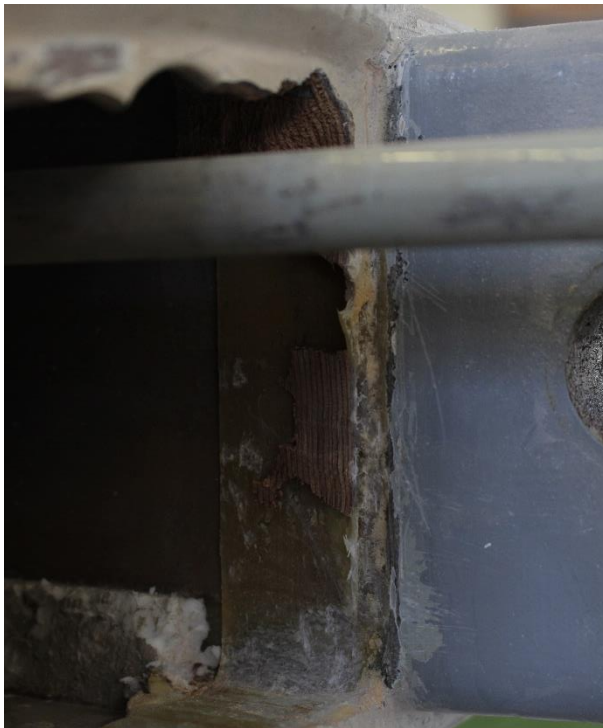
Detail on the bonding of the old wooden rib to the spar. The glass fabrics reinforcing the original rib flanges can be seen. These fabrics including the adhesive between the fabrics and the wing structure must be fully removed.

The original wooden rib of the ASW 15 is reinforced at the bonding flange with glass fabric. These glass layers (2x 92140 & 1x 92110) must be removed completely from the wing shell and the spar if the bonding of the rib is damaged or the space is required for the new rib.

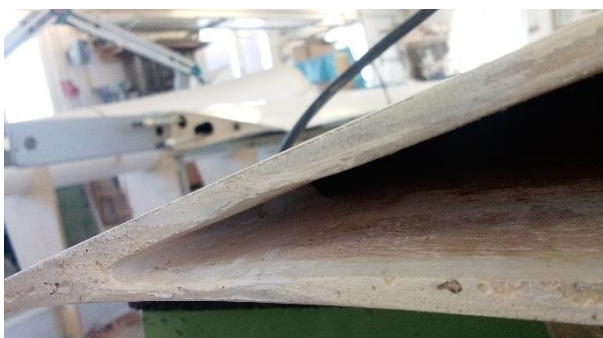
Details on the removed rib in the region of the trailing edge. It is sufficient to remove the old adhesive so that a pin with 6 mm diameter can be placed between the wing shells.

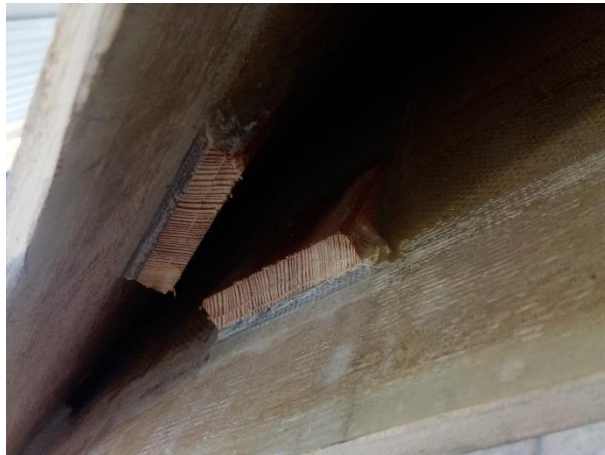
In the region of the lift-pin bushings the wing shell is reinforced with wedge-shaped pine bars. The end of these bars has to be shorted in spanwidth direction so that the new rib can be inserted wide enough in the wing shell. The front surface of the bars should be perpendicular to the rib plane (see point 3.).

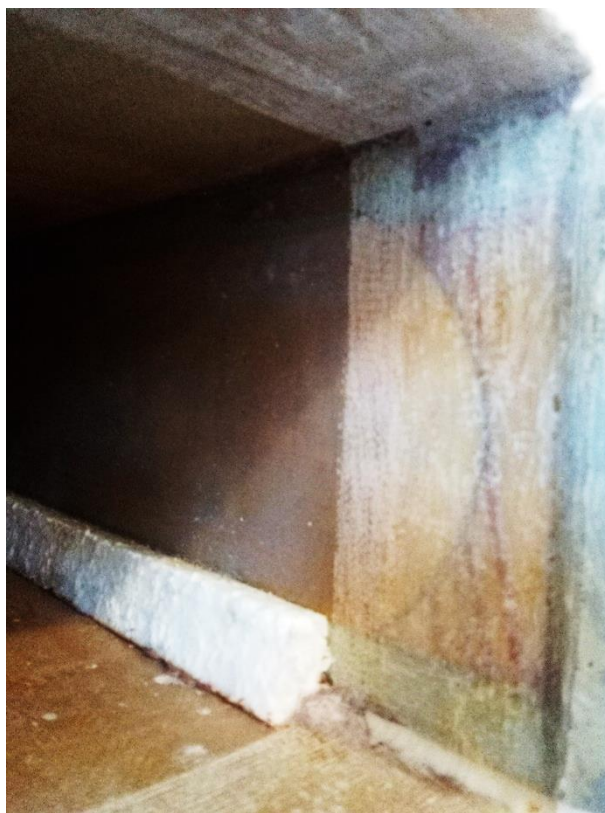
Detail of the removed rib in the region of the wing spar. On the right part of the picture the ending of the winging can be seen. This end is directly at the beginning of the old wooden rib.

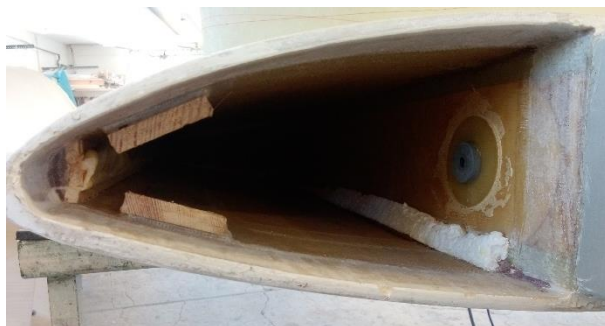
Fully removed old front wooden rib.

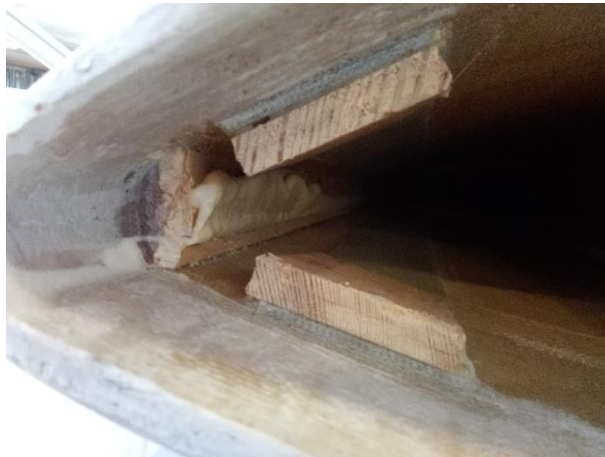
Detail on the removed front wooden rib in the region of the leading edge. In addition to the reinforcing pin bars behind the lift-pin bushings there are further bars at the leading edge which were used to bond the two wing shells. These bars have to be shortened as well up to the required depth.

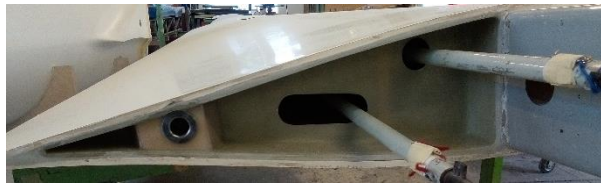
Finally bonded new GFRP rib.

The new ribs are bonded to the wing structure using the adhesive mixture which is defined in the introduction. The usual procedures for handling structural bonds must be observed. The adhesive mixture should be applied on the rib and the wing. Subsequently the rib is slid into the opening of the wing. Through the openings at the rib surplus adhesive can be removed at the inner side.

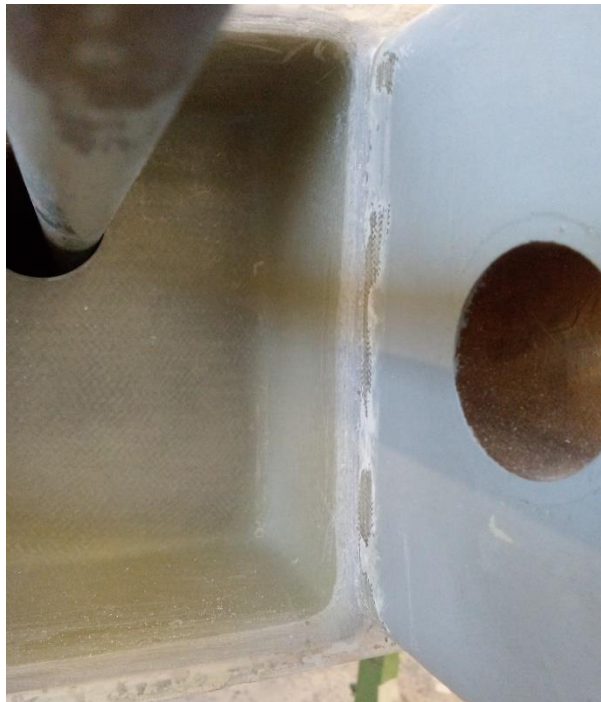
Details of the contact between rib flange und spar winding.

For the bonding of the rib into the wing the lift-pin bushing is placed without adhesive in the drill at the rib. If required, thin tape can be wound around the bushing to adjust the clearance of the bushing in the drill. If the bushing is properly inserted to the rib (be aware of the correct fit of the flange) the jig from step 1 can be used to ensure the correct position of the rib during bonding. At the region of the wing spar, it should be checked that the rib flange is flush with the spar winding.

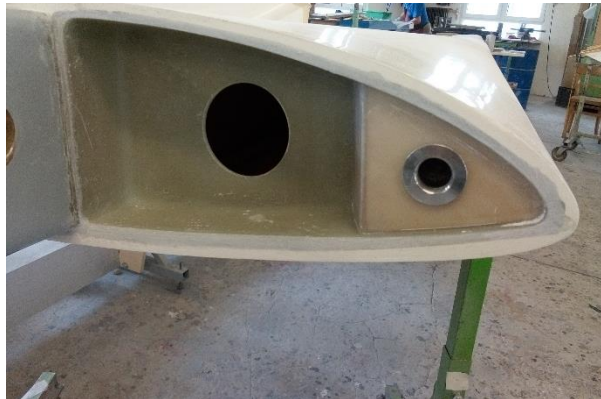
Final front GFRP rib prior to preserving.

In the last working step, the protruding flanges of the rib must be shortened to the edge of the wing shell. Finally, all open GFRP edges (cutting and grinding edges) have to be preserved with epoxy resin.

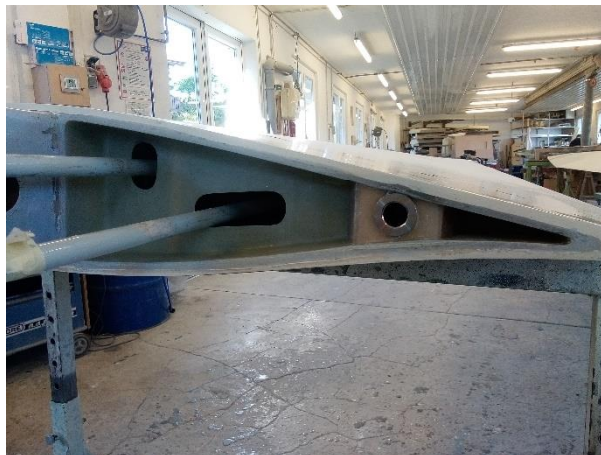
Final rearward GFRP rib prior to preserving.
