Alexander Schleicher GmbH & Co. Segelflugzeugbau

Subject: Cracks in the bonding of the wing root rib

Inspection for cracks in the bonding of spar and wing shell (in the area of the root rib),

Applicability: ASK 21, ASK 21 B, ASK 21 Mi

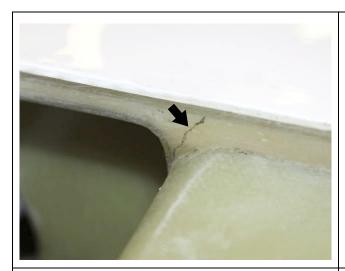
Cracks in the edges:

Cracks can be repaired according **repair scheme 1**, if they are limited to the bonding cement in the edge.

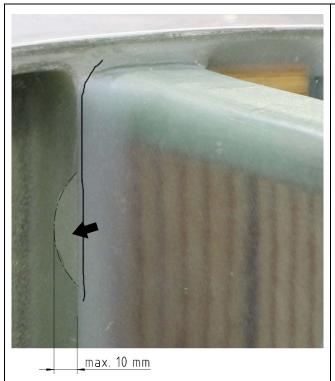
Cracks and a separation between the vertical bonding joint of the root rib and spar:

Cracks and separation can be repaired according repair scheme 2a, if additionally to the cracks a separation of not more than 10 mm (0.4 in) is found.

White markings (delamination) in the structural parts (root rib, shell, spar) and debondings, found by ping testing of the bonding joints, indicate a bigger damage, causing an appropriate bigger repair according TN 02-2005.

The same applies for cracks, which continue deeper than the stated above 10 mm (0.4 in) or even until the rear side of the bonding joint of the root rib. These are signs of structural overloads and are not comparable to the cracks described in this technical note.
