**Issue date:** 25.10.2023

**Subject:** Adjustment of the actuation system for the water ballast valves.

**Applicability:** all ASW 27-18 „ASG 29“ and ASW 27-18 E „ASG 29 E / Es“

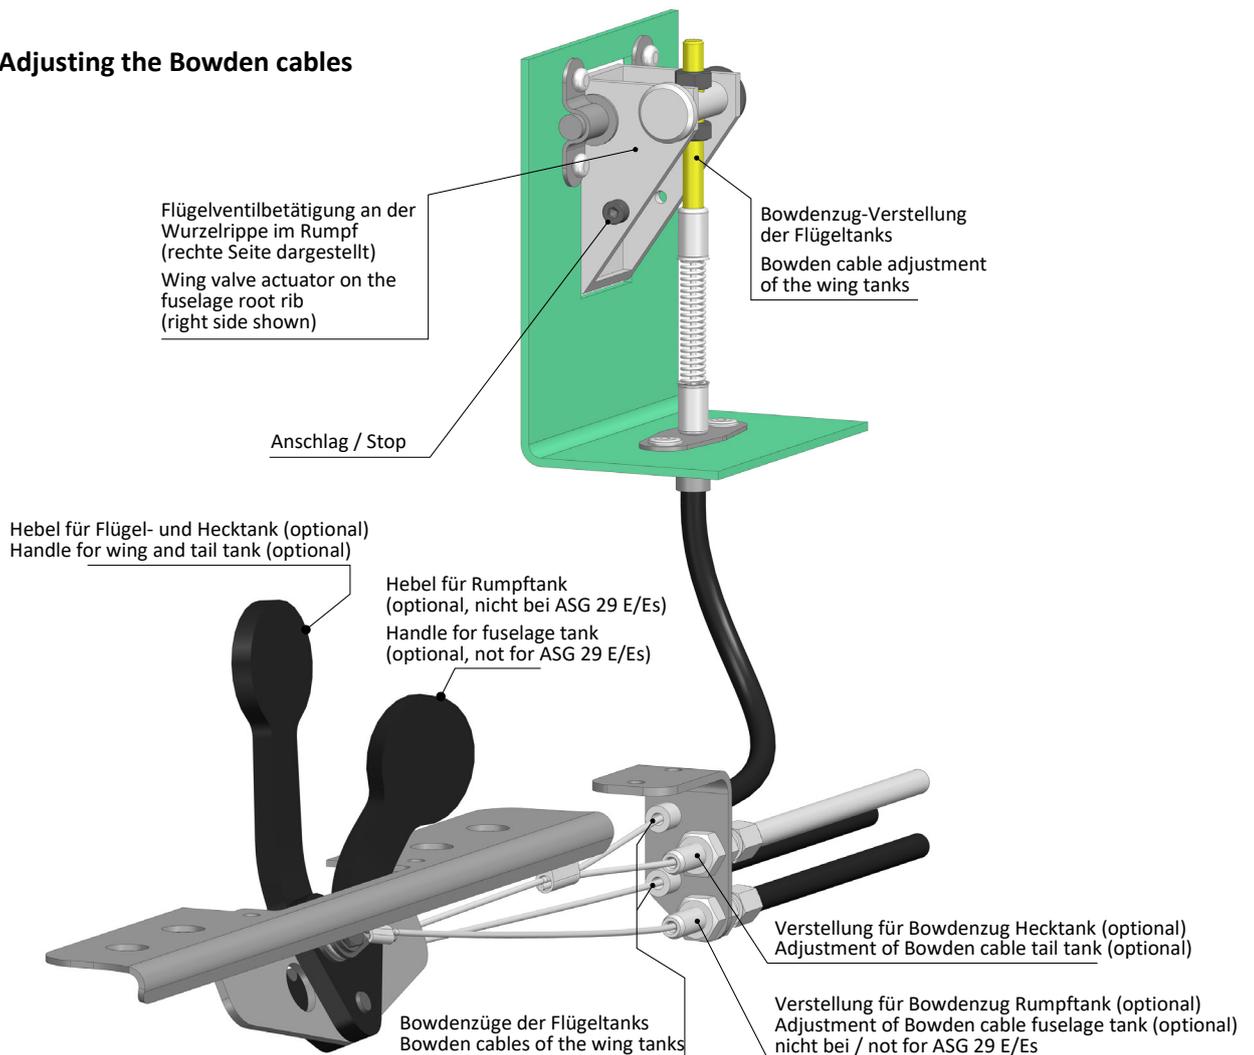
**Fig. 1 – Adjusting the Bowden cables**

For an equal operation of the water ballast valves, the Bowden cables of the system can be adjusted at different positions (see Fig. 1). They must be adjusted in the following manner:

**Wing tanks:** The valve actuator at the fuselage root rib incorporate a stop preventing them from rotating too far out of the fuselage. In the “valve open”-position they rotate nearly up to the stop. The adjustment is made directly on the threaded piece at the end of the Bowden cable (see Fig. 1).

**Tail tank (optional) / fuselage tank (optional, not for ASG 29 E/Es):** The Bowden cables are adjusted such, that they are unloaded / slack in “valve closed” position. They can be adjusted at the mounting bracket behind the handle (see Fig. 1).

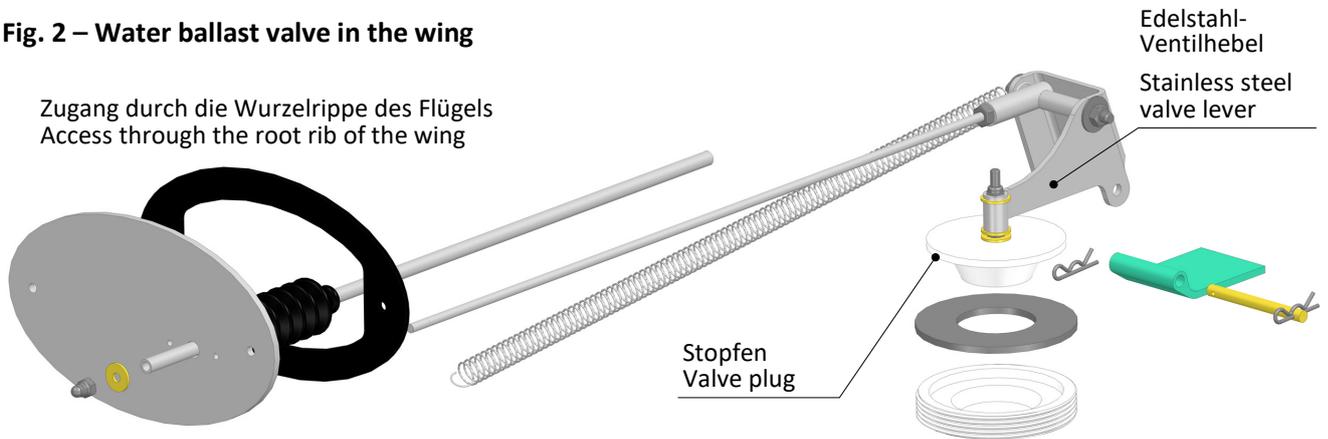
**Fig. 2 – Water ballast valve in the wing**

In case the water ballast valves in the wing do not shut tight, refer to section 2.4 in the maintenance manual. Additionally, it is noted: If a misalignment of valve plug and outlet hole can be spotted through the root rib or through the outlet hole, appropriate bending of the stainless steel valve lever possibly can improve the situation (see Fig. 2). However, this is only possible for aircraft equipped with such a stainless steel valve lever.
