Flight Manual

Operating Manual

3 Inspection of the elevator

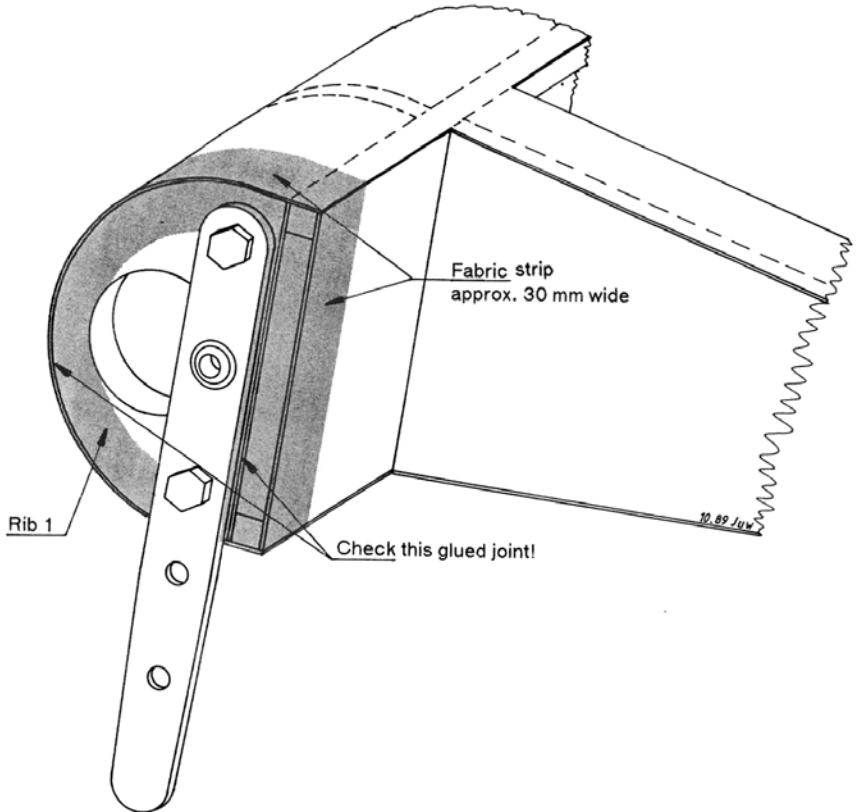
Fig. 3-1 Right half of the elevator

Failures of gluing attachment of the elevator due to aging or overloading have increasingly been found. Since this area is essential for the safety of the aircraft, the inspection must be carried out with great care.

5. If no damage on the glued joint is found, the edge must be covered once again after the inspection with a fabric strip as shown in Fig. 3-1. Finally, apply weather and moisture protection (painting).

As an alternative to the fabric strip made of cotton the use of ORATEX UL600 is approved. In this case, the additional weather and moisture protection (painting) is not required. The "ORATEX® Application Manual & Airplane Maintenance Manual Supplement" in its latest approved revision has to be observed.
