Inspection program for extending service life1. General information

Checking and securing the L'Hotellier quick-close connections of the control circuit1. Securing

Inspection, maintenance and adjustment of the tow hook

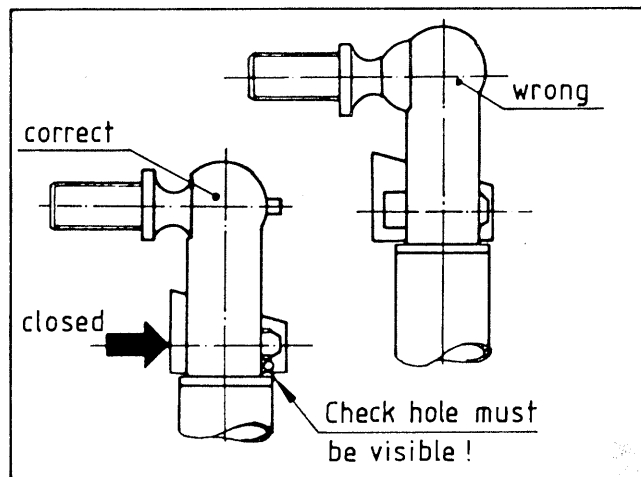
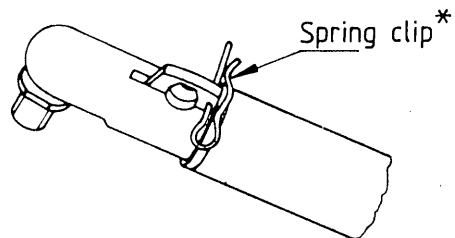
The experience of the past shows that mostly the connection of the elevator was incorrectly fitted or even worse simply was forgotten. A sticker on the fin serves to remind the pilot of the correct connection; in addition the securing by means of a spring pin is recommended.

To do this on older ASW 19 gliders the check hole must be drilled to 1,2 mm in diameter.

Aileron, flap and airbrake connections in the fuselage can be safetied by the same method.

*Spring pin no.50030771 can be ordered from Alexander Schleicher or from A.Würth, P.O.Box 1261, 7118 Künzelsau, F.R.Germany.

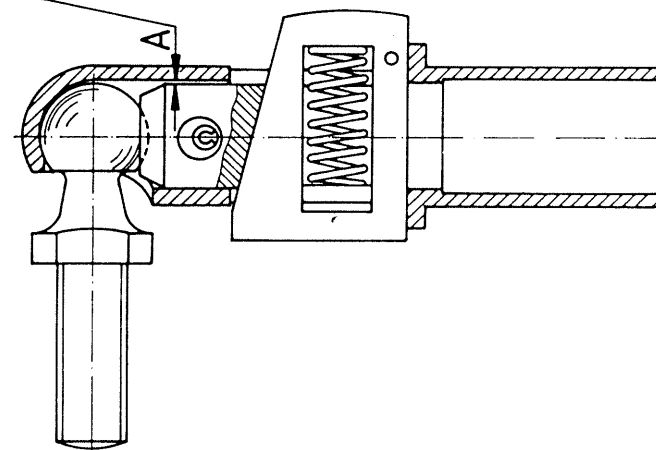
Clearance A must not exceed 0,15 mm (0,006 in);
check by using a wire of 0,15 mm diameter !

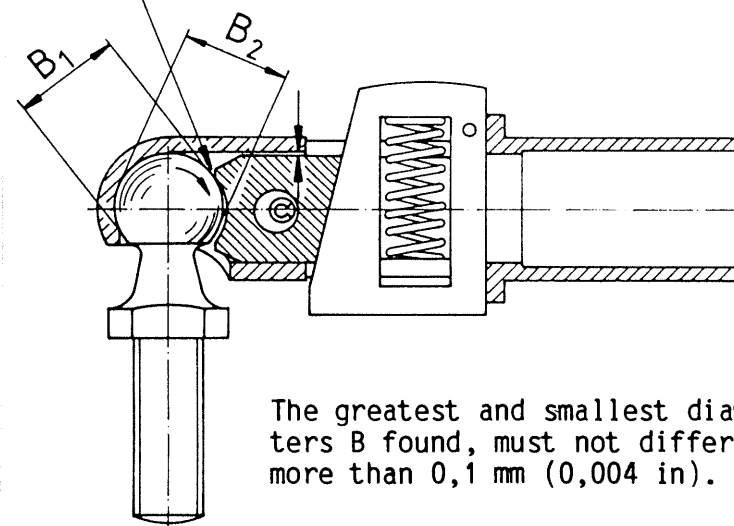
Bad wedging effect causing wear of the ball end.

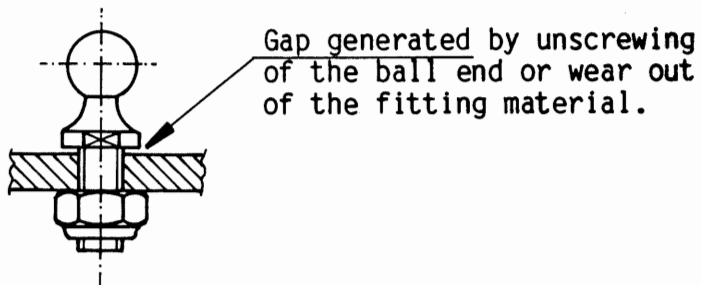
The greatest and smallest diameters B found, must not differ by more than 0,1 mm (0,004 in).

The tight seat of the ball ends inside the fittings must be checked, as loose ball ends may be broken due to bending loads in the thread area.

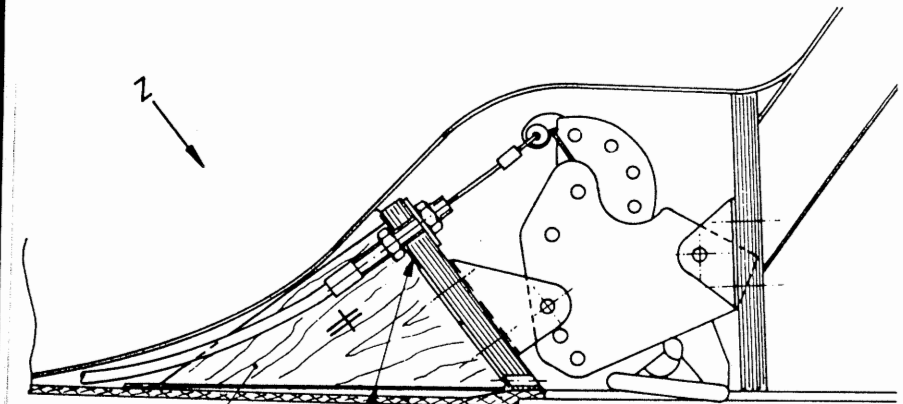
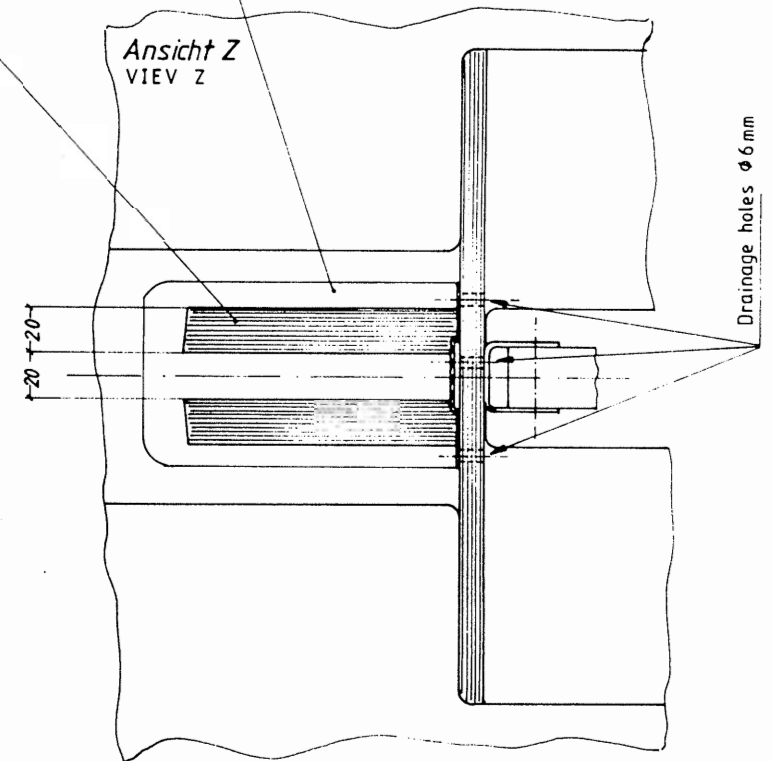
Reinforcement
Verstärkung
Sph. 6.1013. Plywood

b) After a belly landing and/or if water has been allowed to stand in the cockpit for a long period, the glued joint between the rear tow hook bulkhead and the fuselage shell may fail. This weakens the tow hook installation to the point where the tow hook may twist under a severe load (such as occurs during cable snatches); this movement may be enough to cause a stiff and/or too critically adjusted tow hook cable to open the latch of the tow hook.

A successful reinforcement to the forward tow hook bulkhead of the C.G. tow hook has proved to be two wedge-shaped plywood blocks (see sketch on page 40h). Two layers of glass cloth 92140 are laid over the joint surfaces of the blocks, with random fiber orientation, and resined together.

2 Lagen 92140, beliebig
2 layers 92 140, any fiber orientation
