ASK 21 Maintenance Manual

TN24 /04.05.92 Juw

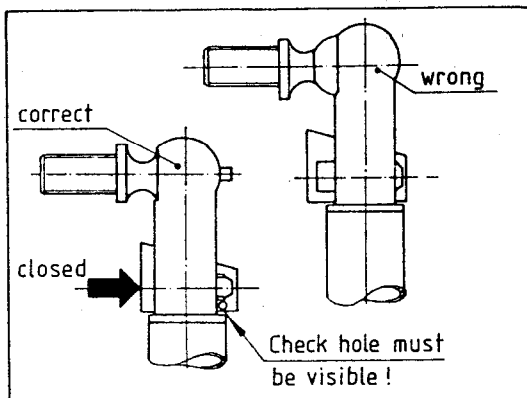
Fig. 1

Past experience showed that the quick-release connectors in the airbrake, aileron and particularly in the elevator control linkages were incorrectly assembled or that their assembly was even completely forgotten (as of serial no. 21206 the aircraft was then supplied with an automatic elevator connection). A sticker (Fig.1) fixed to the fin and the access hole cover, serve to remind the pilot of the correct assembly. All quick-release connectors must be secured in addition by means of a spring clip (Fig.2). With the older type of connectors the check hole must be drilled to approx. 1,2 mm ϕ for this purpose.

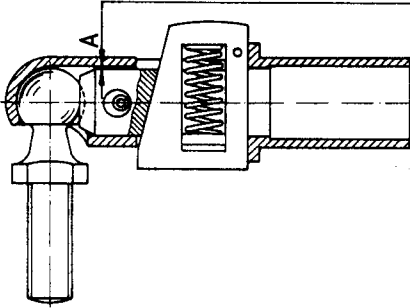
As experience accumulated in Australia has shown, the condition of the L'HOTELLIER quick-release connectors must be checked on every annual inspection of the aircraft, especially when it has been operated frequently and from sandy airfields.

Clearance A must not exceed 0,15 mm (0,006 in); check this by using a wire of the above diameter!

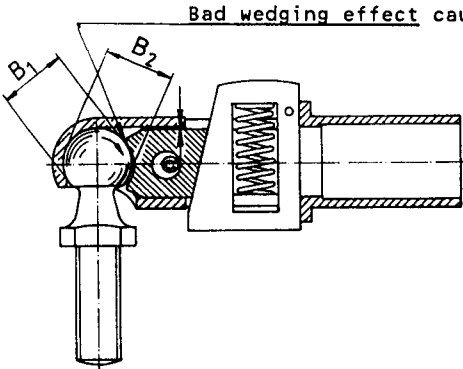
Bad wedging effect causing wear of the ball.

The greatest and smallest diameters B to be found must not differ by more than 0,1 mm (0,004 in).

The tight seat of the ball ends inside the fittings must be checked as loose ball ends are likely to break under bending loads in the thread area.

Gap generated by an unscrewed and incorrectly refitted ball end or owing to overloading /wear out of the lever part.
