ASW 28-18

Maintenance Instruction A Issue 1

Alexander Schleicher GmbH & Co. Segelflugzeugbau D - 36163 Poppenhausen

Replacing of the elastic fairing tapes (elastic lip seal) at the control surface gaps of aileron, horizontal and vertical tail.

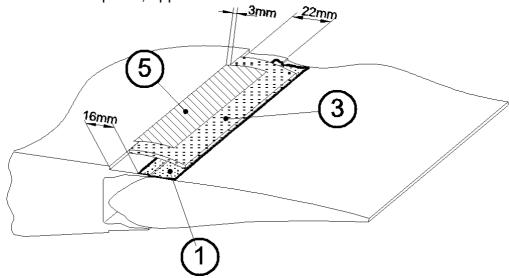
Fig. 2 - Horizontal tail plane, upper surface

This protective tape serves to prevent the detachment of the front (leading) edge of the elastic fairing tape (elastic lip seal) which might result in dangerous flight characteristics.

For the horizontal tail in addition (see Fig. 2), a protective adhesive tape (5) is applied over the abutment of the front edge of the elastic fairing tape (3) and the step in the stabilizer. This tape should be as thin and moisture proof as possible; an example of a suitable tape would be white Tesa film No.104, 25 mm wide.
