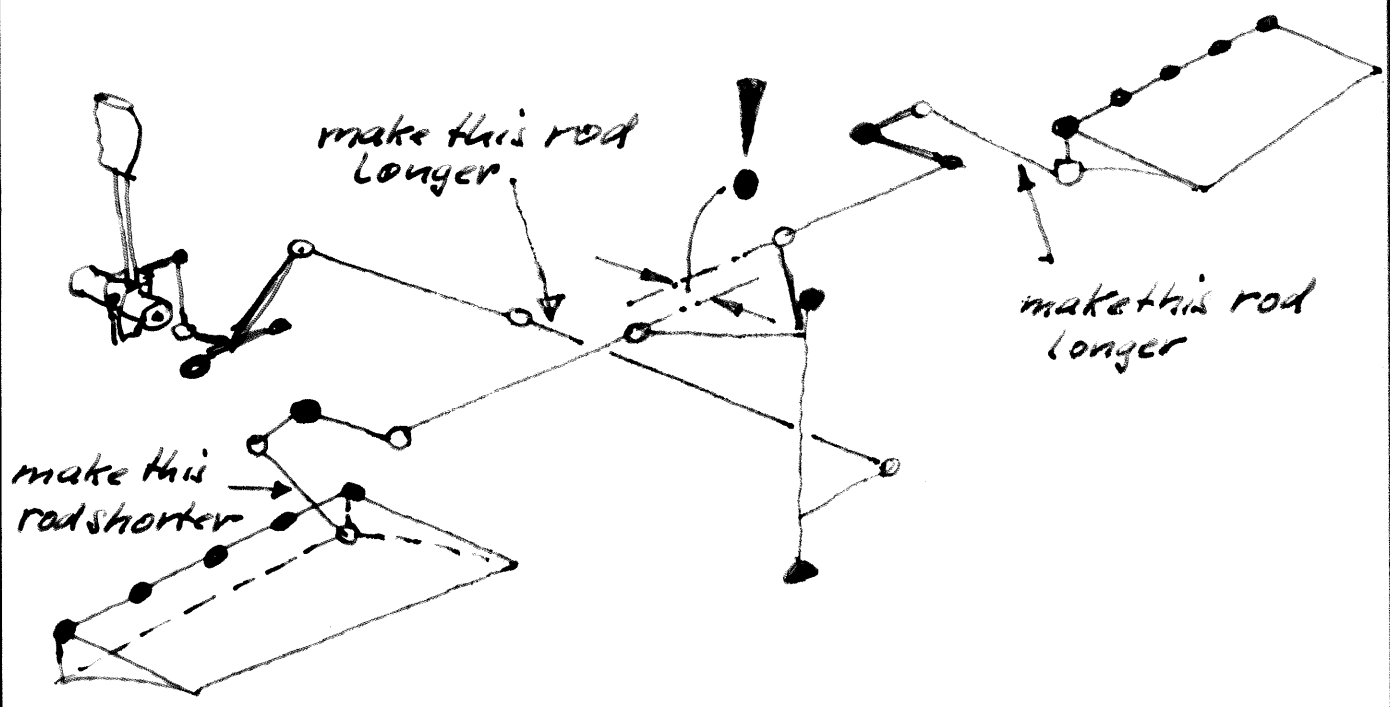
1. Glider makes right turns stickfree.
2. In level flight increasing stick force to the left must be applied with increasing speed.

Reason: Installation of aileron-control-crank in the fuselage not symmetric.

Correction: Push pull rods at the ailerons must be corrected, afterwards the stick must be corrected to zero position.

For left turns (stick pressure to the right) observed opposite corrections must be made.
