Subject: Check of the safety of the aileron hinge pins.

Applicability: All ASW 28, LBA - Document No. 423, Serial Number 28001 through 28029, except for 28001, 28008, 28023, 28025, 28026 and 28028, which are already checked.
From serial number 28030 onwards appropriate checks were done prior to delivery.

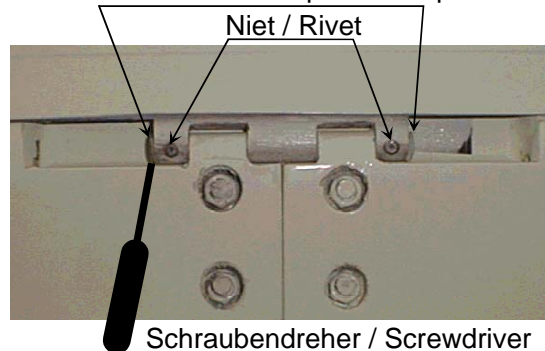
Fig. 1 QR-Antriebslager / aileron actuator
Bolzen mit kl. Kopf / Clevis pin

Action: **1)** For inspection of the aileron hinges the Mylar cover on the lower wing surface must be carefully lifted. The sealing Teflon tape underneath must be cut in flight direction with a sharp knife between the head of the clevis pin and the wing side hinge fitting, just big enough, that a screw driver can be entered between pin head and fitting and when entering is possible, by rotation of the screwdriver attempting to move the pin in span direction. Check at the same time, if the safety rivet is loose (see Fig. 1 & 2).
When the screwdriver can not be entered and the safety rivet is tightly in place, no further action is necessary.
When all hinge pins can not be moved, the ASW 28 can be put back to operation. The small cuts in the Teflon tape can be sealed by some grease and the elastic Mylar cover must not be distorted.

2) Loose and/or not correctly engaging safety rivets must be exchanged against new blind rivets with flat round head (= Flachrundkopf in German) of the dimension diameter 2,4mm x 5 mm long, according to DIN 7337 A to secure the hinge pin. During setting the rivets apply some force to the rivets, so that they are additionally pushed into the holes. Reset the tool when necessary. Check the hinge pin and safety rivet. Now apply a new Teflon sealing tape as well as a new Mylar cover as it may have been damaged too much. Partial replacement in sections is possible.

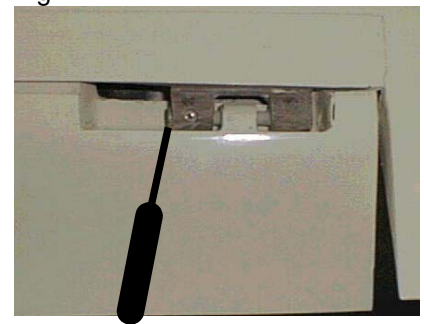
Fig. 2

Schraubendreher / Screwdriver
