ALEXANDER SCHLEICHER KG Segelflugzeugbau Poppenhausen/Wasserkuppe	Technical Note Powered glider ASK 14 L - 684	No. 1

Subject: Suspension of the thermosbottles below the baggage compartment.

Effectivity: All serial numbers up to 14004.

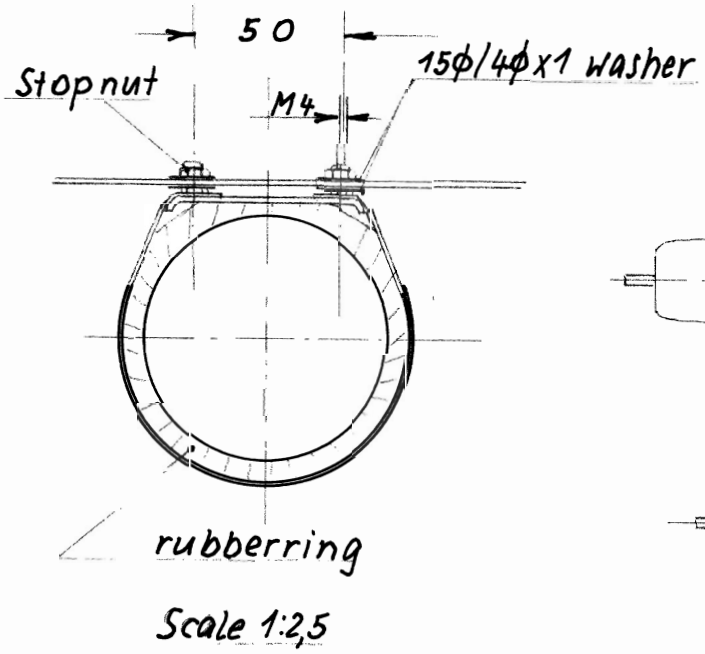
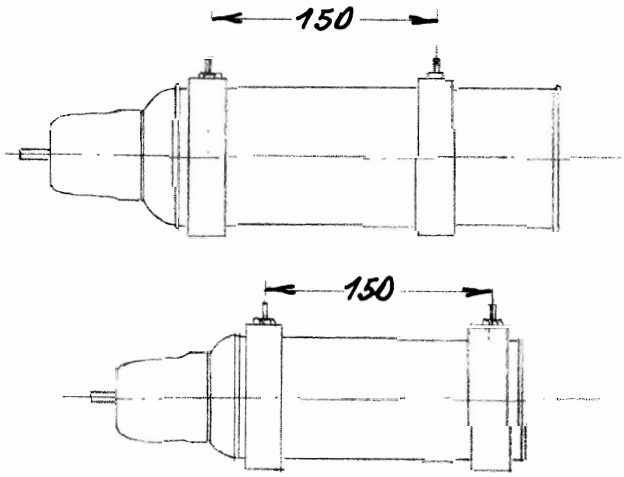
Reason: There is the suspection, that a bottle got loose and blocked the controls.

Instructions: Remove the bottle and cut off the present screws. Put the new suspension bands over the bottle and push the rubber ring between. Bring the bands to the correct distance, see sketch. Thrill the holes in the plywood from above, so that the bottles come at their old place. If there is any equipment it should be removed for that work. Install the bottles. There must be a 15 mm dia. washer at both sides of the plywood. Connect the bottles in the correct sense to the instrument lines.
