Checking and securing the L'Hotellier quick-close connections of the control circuit

Inspection program for extending service life

Inspection, maintenance and adjustment of the tow hook

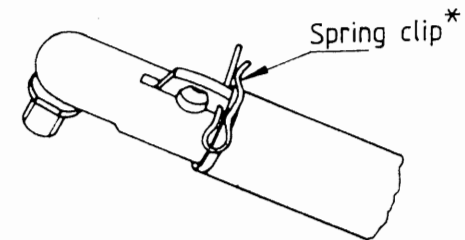
The experience of the past shows that mostly the connection of the elevator was incorrectly fitted or even worse simply was forgotten. A sticker on the fin serves to remind the pilot of the correct connection; in addition the securing by means of a spring pin is recommended.

To do this on older ASW19B gliders the check hole must be drilled to 1,2 mm in diameter.

*Spring pin no.50030771 can be ordered from Alexander Schleicher or from A.Würth, P.O.Box 1261, 7118 Künzelsau, F.R.Germany.
