Instructions For Continued Airworthiness Schleicher ASK 21

Inspection and Replacement of Brake Linings

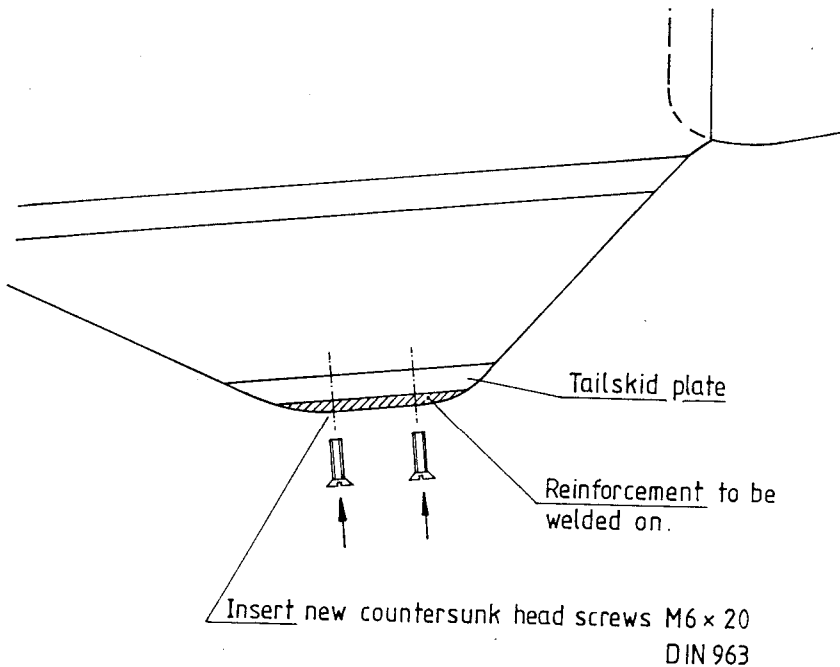
Check wear and either reinforce in time the tail plate by welding on sheet steel or replace it by a new one. Remove the tailskid plate for the welding job.

The rubber tailskid is designed so that it will shear away from the fuselage with strong lateral forces. It may be glued on again or be repaired by use of contact glue. It is important to seal the glue seam between rubber and fuselage with tape in order to prevent that long grass will be peeled off or will cut into the seam.

Reinforcement of the tailskid plate

Watch the wear of the tail skid metal plate and either reinforce it in time by welding on sheet metal, or replace it by a new one. Remove the tail skid plate for the welding job.

The rubber tail skid is designed so that it will shear away from the fuselage with strong lateral forces. It may be glued on again or be repaired using contact glue (Pattex). You must apply plasticised fabric adhesive tape over the gap (glue joint) between skid and fuselage in order to prevent long grass from being caught.

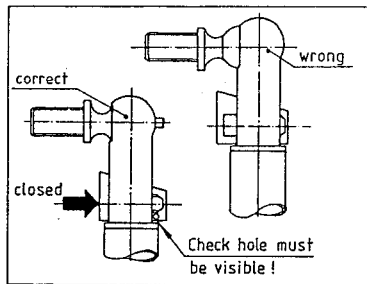
Fig. 1

Past experience showed that the quick-release connectors in the airbrake, aileron and particularly in the elevator control linkages were incorrectly assembled or that their assembly was even completely forgotten (as of serial no. 21206 the aircraft was then supplied with an automatic elevator connection). A sticker (Fig.1) fixed to the fin and the access hole cover, serve to remind the pilot of the correct assembly. All quick-release connectors must be secured in addition by means of a spring clip (Fig.2). With the older type of connectors the check hole must be drilled to approx. 1,2 mm ϕ for this purpose.
