Action: Subject: Reason: Compliance: Affecting: 앜 N 1. This is checked by connecting the brakes individually and marking the point on the operating lever gate in the cockpit at which the linkage's dead center occurs. Both dead points should be within 5 mm (0.2 in) ing of the airbrakes. Each airbrake has its own toggle in the wing. For this reason it must be checked that both airbrakes lock simultaneously and securely. It is important to check in regular intervals the lock-As required All ASK 21 serial no.s. Re-adjusting the airbrakes If you observe that the airbrakes do not have an even over-center lock, the toggle over dead center must be If the airbrakes still do not have sufficient dead again as described under point 1.). 1 turn. Re-connect in the reverse order and check As shown in Fig.1 the short pushrod (1) is to be disconnected from the toggle crank (2); back off the lock-nut (3) and screw out the pushrod (1) by 1/2 to readjusted. This must be done with the airbrake push-rod disconnected from the HOTELLIER ball quick-disconof each other and, in the locked state, the individual brakes should still have 10 mm of free movement of the front lever forwards in the gate. nect. Main

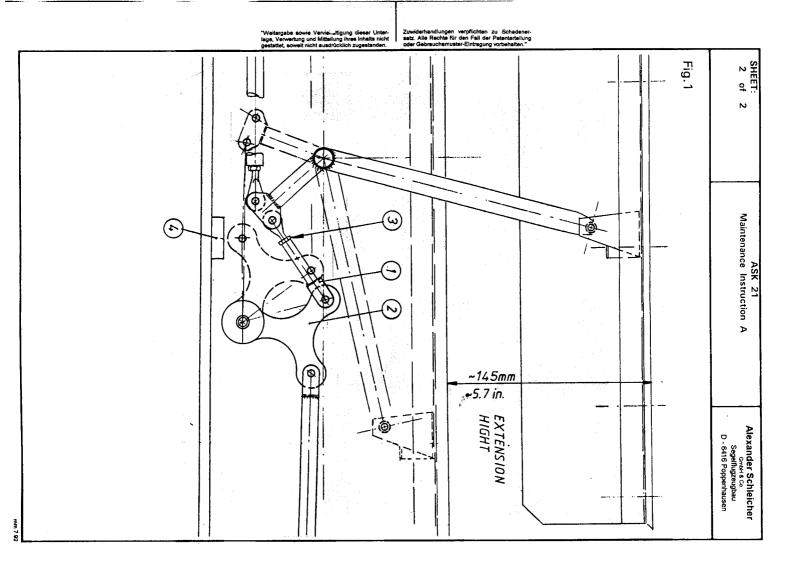
New safety nut NM 6, DIN 980-6, if needed. block (4). Using a punch carefully remove some layers from the stop block (4); then again readjust the airbrakes as described under points 1.) and 2.). ALEXANDER SCHLEICHER stop
