ASH 31 Mi

Maintenance Instruction A Issue 2

Subject: Replacing the elastic fairing tape at the control surface gaps of ver-

tical & horizontal tail, aileron, flaps and at the gaps of the engine

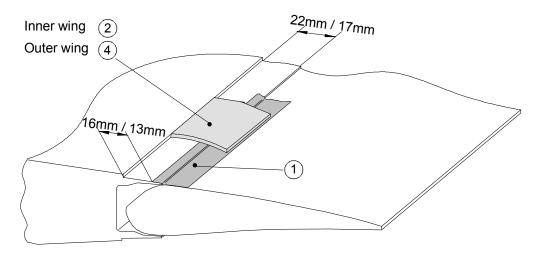
Fig. 1 (Wing lower surface)

Apply the sealing/slip tape [1] with a clearance of 16 mm (inner wing and horizontal tail) resp. 13 mm (outer wing) to the front edge of the recessed step. Be careful that the sealing/slip tape lies slack over the gap and that flap and aileron are set to maximum negative deflection (whereas the elevator must be set to maximum positive deflection) so that later the Teflon sealing/slip tape is not stretched during normal full control deflections, so as to prevent full deflections.

Apply full deflections several times so that the sealing/slip tape [1] fits well into the gap; it must be firmly rubbed down on to the surface!

Then peel the protective backing from the elastic fairing tape, and firmly stick the fairing tape into the recessed step of the wing lower surface resp. stabilizer upper surface, leaving no gap at the front edge. Use fairing tape 38/15 [2] & [8] for the inner wings lower surface resp. stabilizer upper surface and the elastic fairing tape 30/12 [4] for the outer wings lower surface. The fairing tapes for the wings are scarfed on their trailing edges.

Finally, press the adhesive zones of the elastic fairing tape [2], [4] and [8] firmly down on the surface by means of a soft wooden block (e.g. Balsa) or a hard rubber roller!

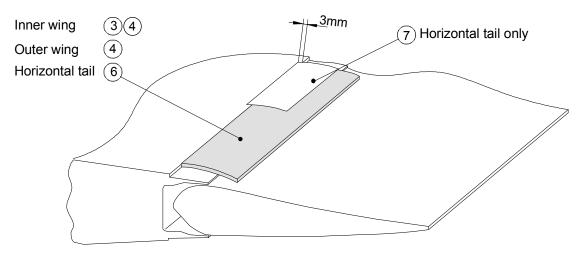
Fig. 9 (Wing upper surface and horizontal tail lower surface)

Remove the backing from the elastic fairing tape, and firmly stick the fairing tape into the recessed step of the wing upper surface resp. stabilizer lower surface, leaving no gap at the front edge. For the inner wings upper surface use fairing tape 25/12 [3] until the end of the flap, in the area of the aileron use fairing tape 30/12 [4]. Also use fairing tape 30/12 [4] for the outer wings upper surface, and fairing tape 22/15 [6] for the horizontal tail lower surface. The fairing tapes for the wings are scarfed on their trailing edges.

Finally, press the adhesive zones of the elastic fairing tapes [3], [4] and [6] firmly down on the surface by means of a soft wooden block (e.g. Balsa) or a hard rubber roller!

Only for the stabilizer in addition, a protective adhesive tape [7] is applied over the joint of the front edge of the elastic fairing tape [6] and the recessed step in the stabilizer.

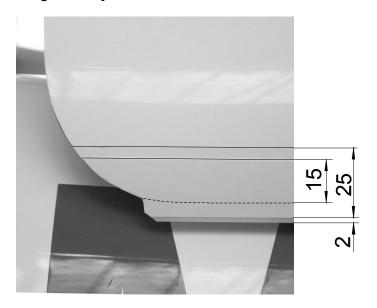
Fig. 10 Engine bay doors, rear end

Fig. 11 Engine bay doors, front end

The elastic fairing tape 22/15 [6] is adhered along the lower edge of the engine bay door with an overhang of 7 mm (only the 15 mm wide adhesive film of the elastic fairing tape is on the engine bay door). The protective adhesive tape [7] is positioned 2 mm backwards to the edge of the elastic fairing tape.

At the kink of the engine bay doors, the elastic fairing tapes will be cut to mitre. The protective adhesive tape overlaps the mitre cut about 5 mm.

The ends of the elastic fairing tapes will be cut off as shown in Fig. 10 and 11
